Fairfield nursing home, Edwalton, Nottinghamshire, December 1975

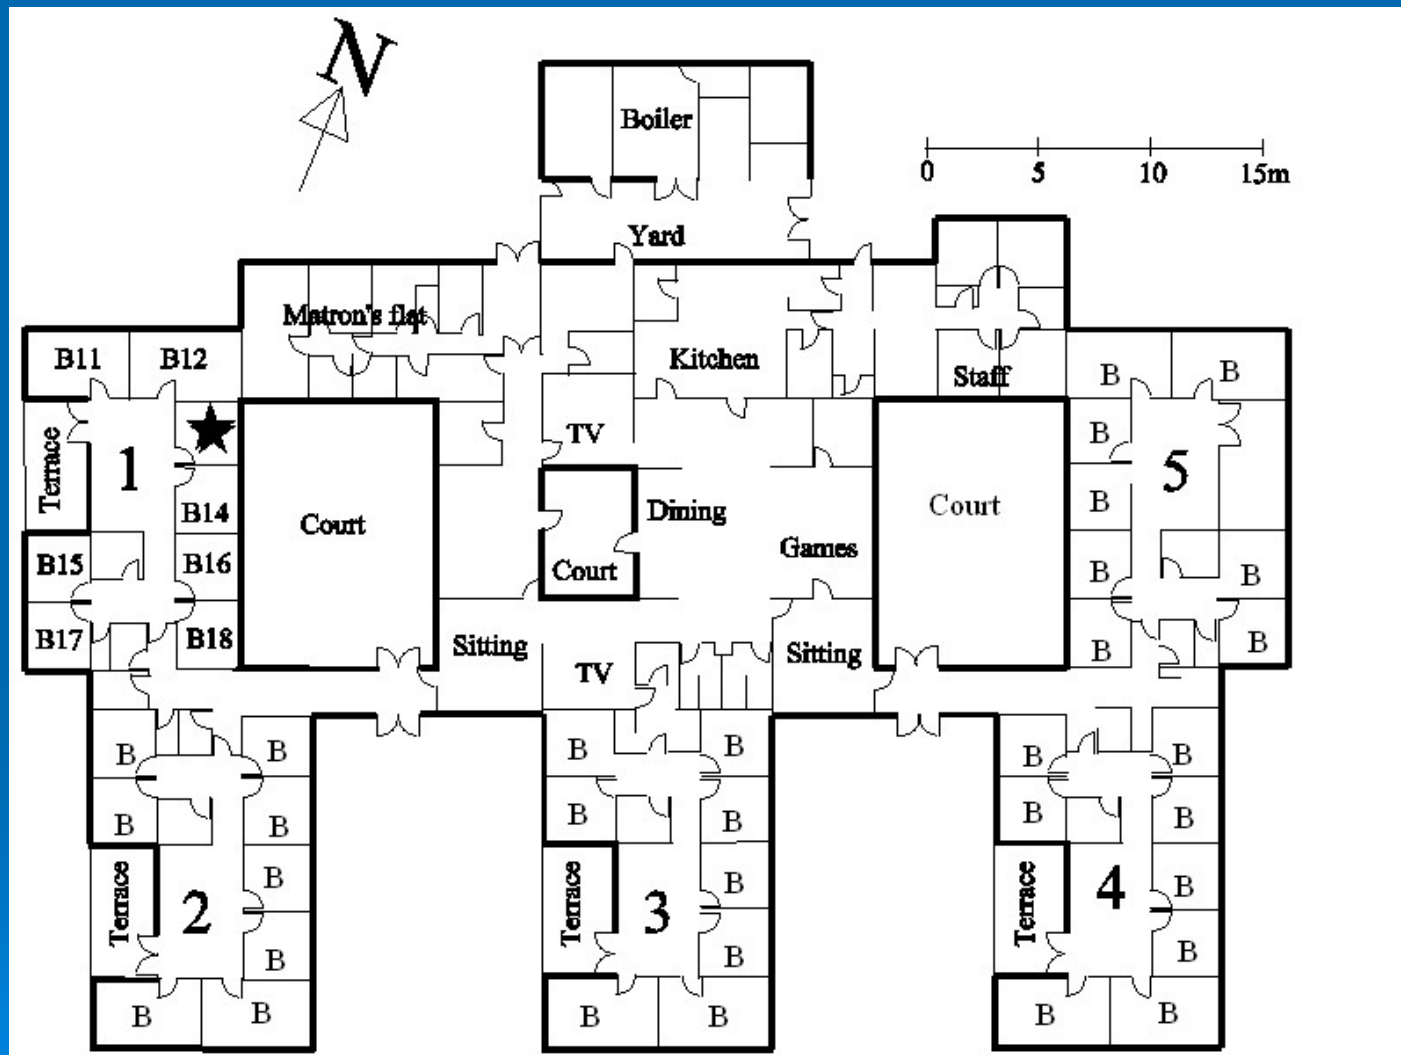
Fairfield – plan of houses

(Asterisk shows origin of fire)

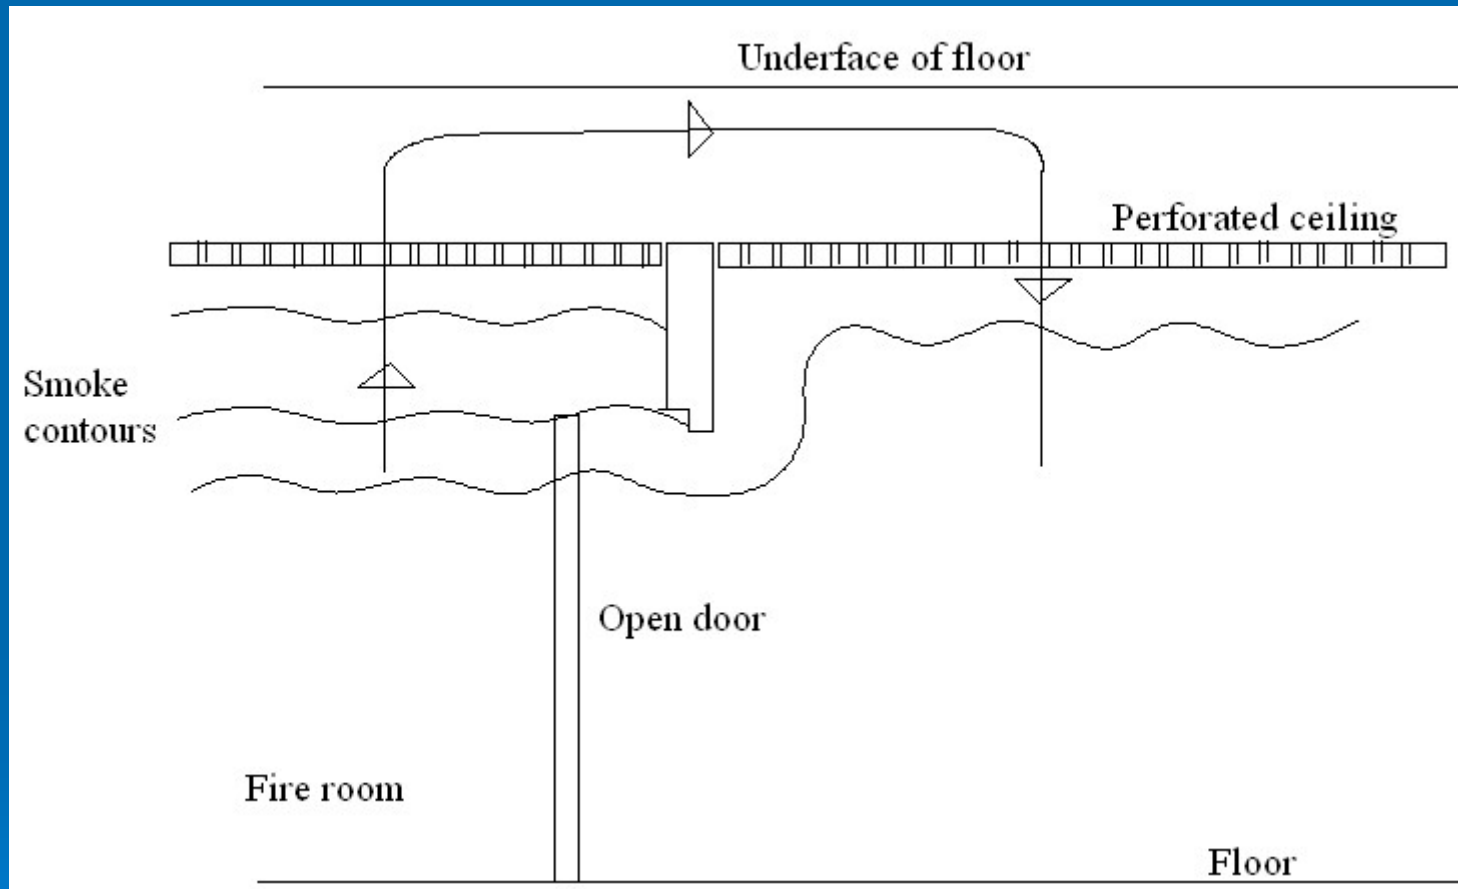
Fairfield – smoke paths

- CLASP building had no cavity barriers above the ceiling
- Two competing smoke paths – one through perforated ceiling, other through open doors along corridors and into open bedroom doors

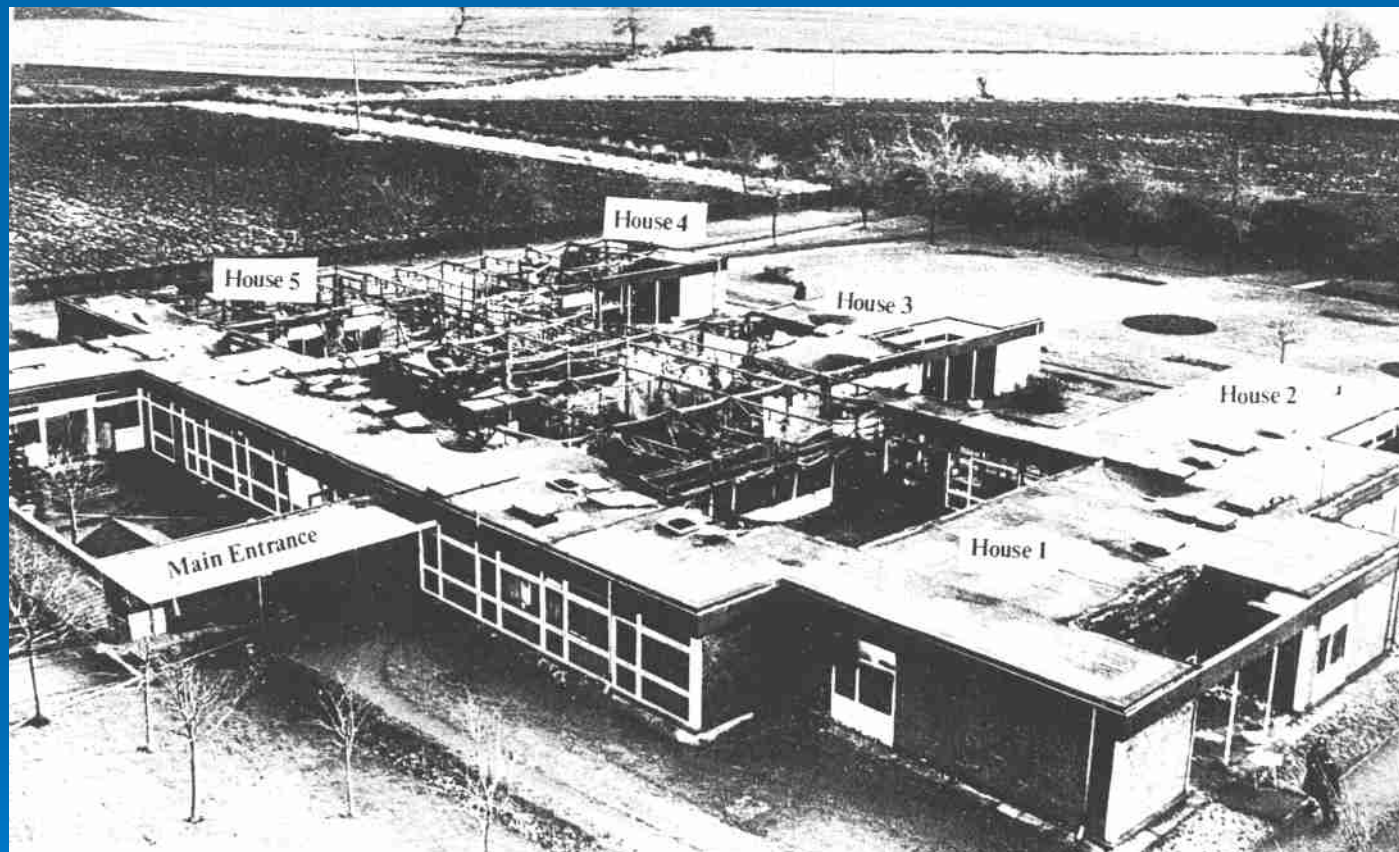
Fairfield – fire spread damage

- Fire started in House 1 and eventually spread to House 4 where most structural damage was done.
