Flixborough petrochemical plant, 1974

Flixborough – the site

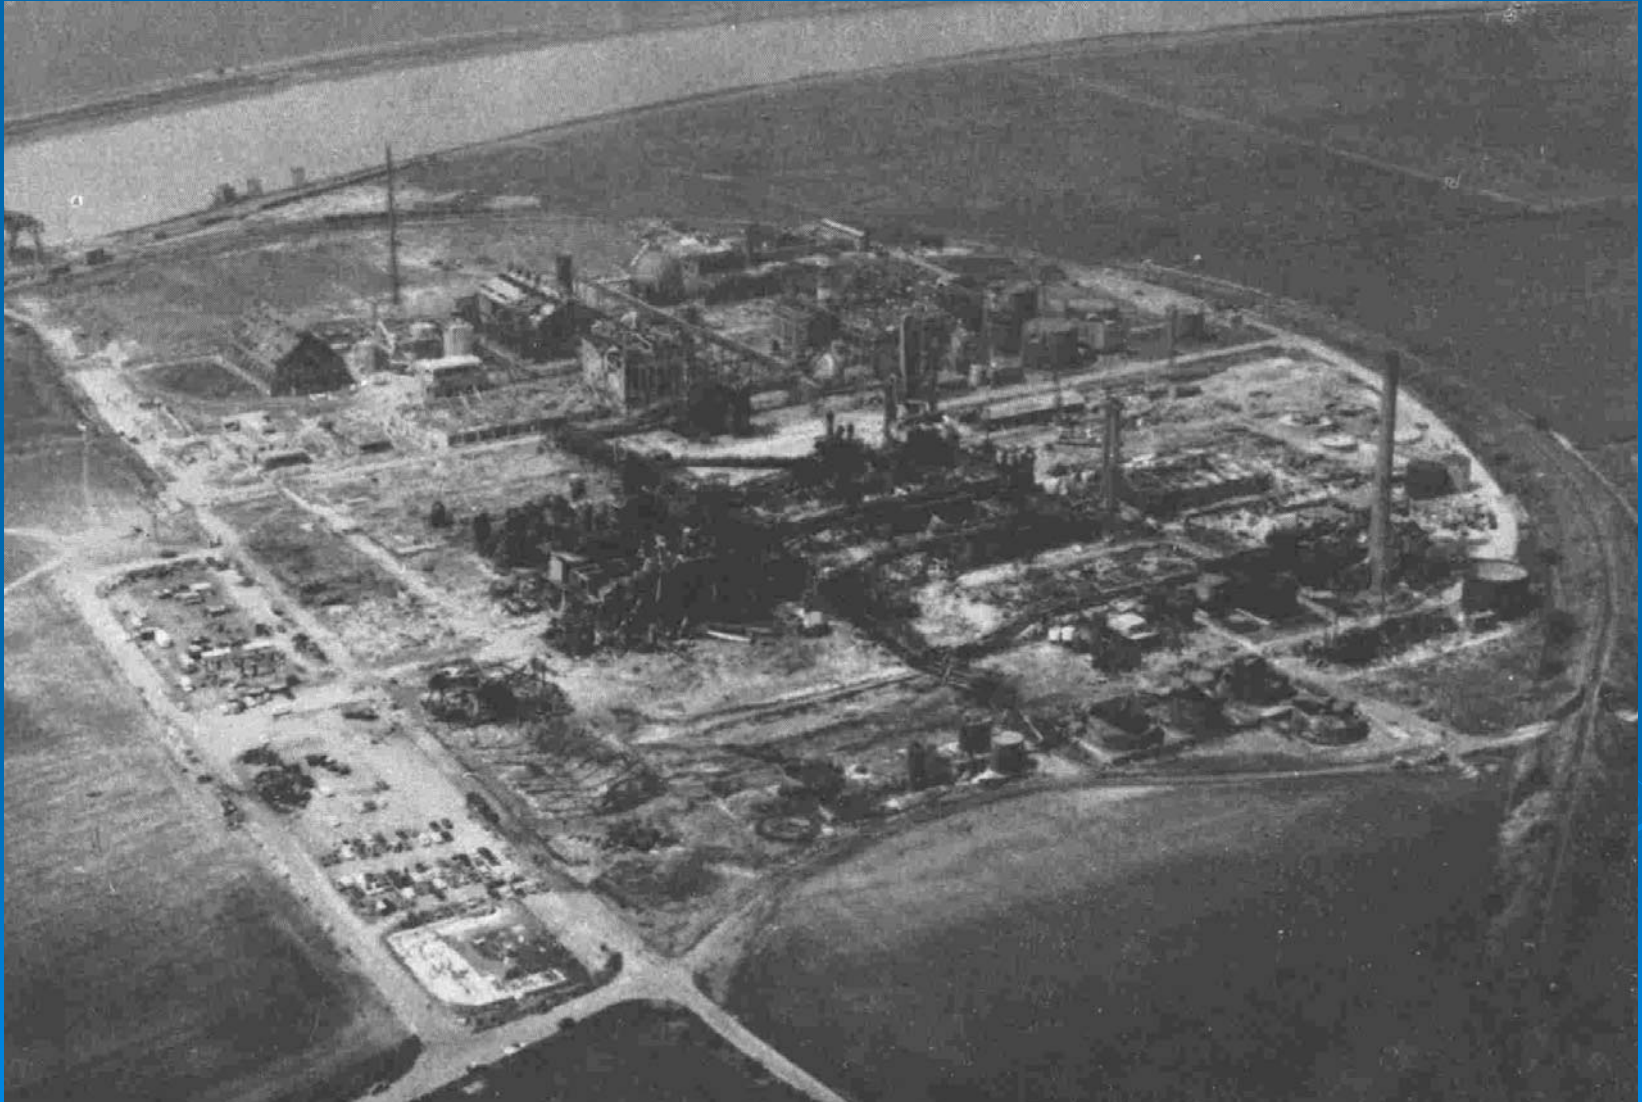
After the explosion

- The Flixborough works of Nypro (UK) Ltd were virtually demolished by an explosion of warlike dimensions on the afternoon of Saturday 1 June 1974.
- The explosion was estimated to be equivalent to the force arising from 15 – 45 tons TNT. This was due to ignition of a vapour cloud which formed when pressurised cyclohexane (a petrol-like substance) escaped from a reactor, vaporized and ignited.
- On site 28 people were killed and 36 injured; if the explosion had occurred during the week there would have been many more casualties.

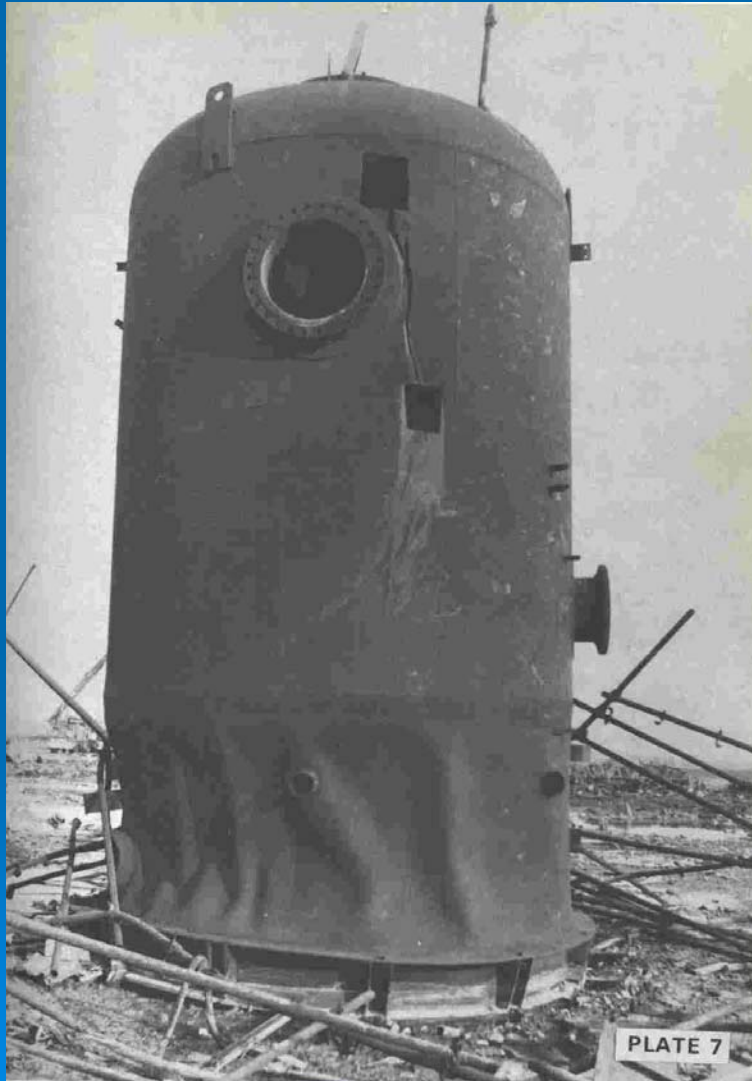
Flixborough – defective pressure vessel

- Failed pressure vessel taken out of service. Note crack propagation near flange.
- Square holes are where material has been removed for examination

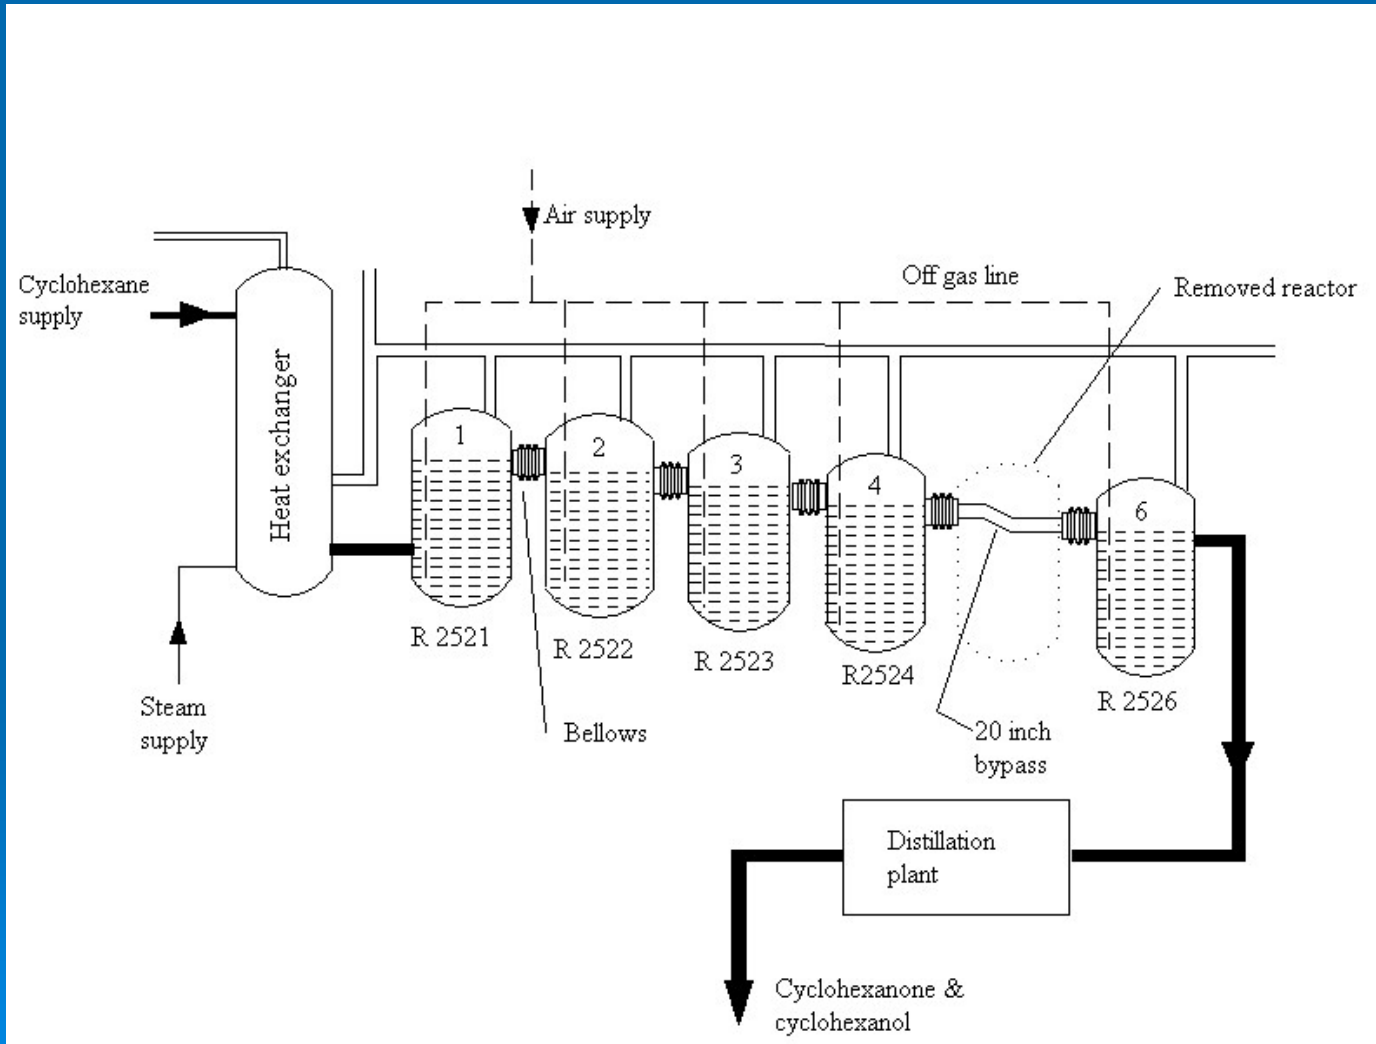
Flixborough – Section 25

Shows removed pressure vessel replaced by standby pipe.

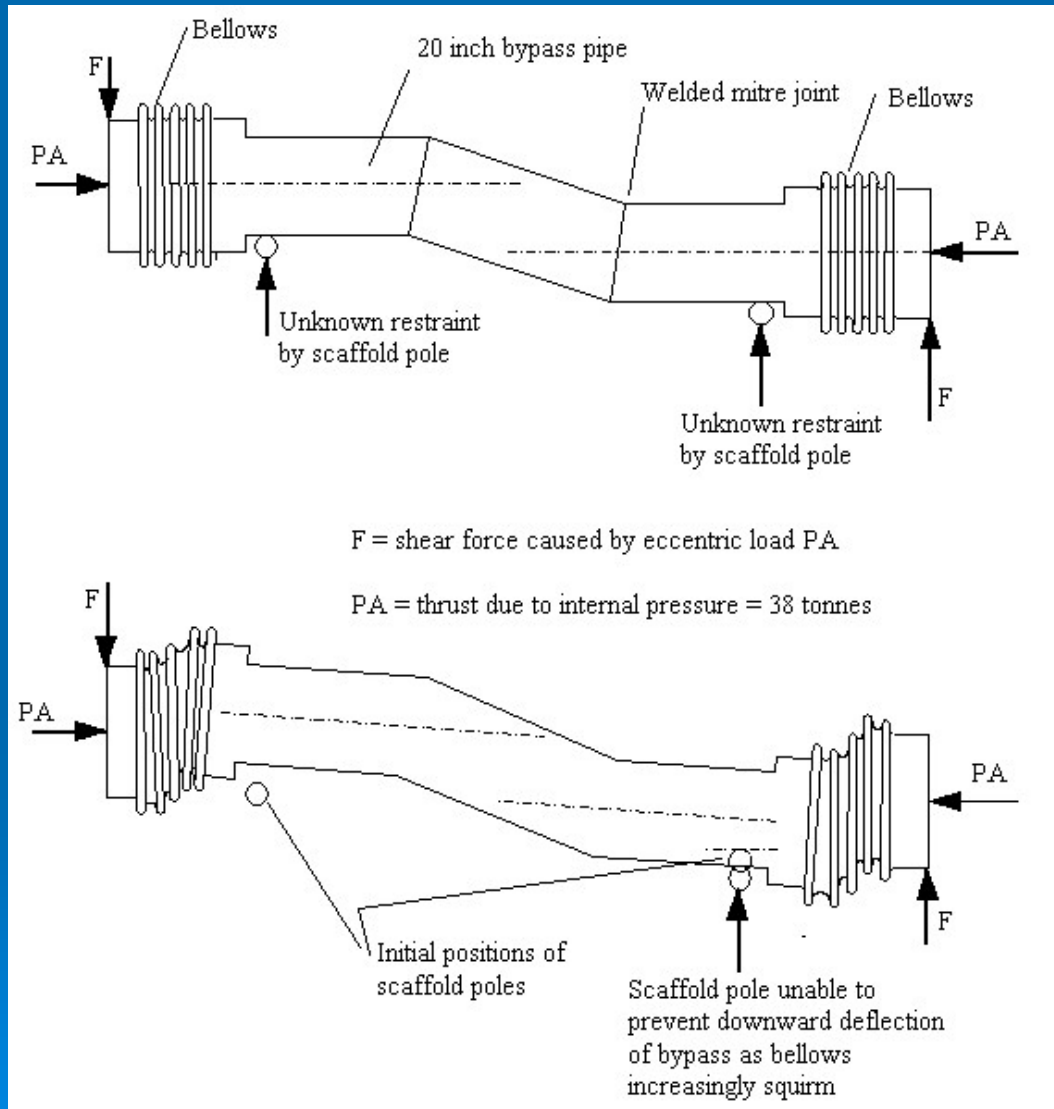
Flixborough – bypass pipe

- Details of the support for the cranked bypass pipe.
- Pipe was supported by scaffolding poles. As pressure built up the bellows displaced vertically downwards at one end and failure occurred by 'squirming' and rupture of the mitred welds.
- The by-pass had not been properly designed (effect of axial force apparently overlooked).
- The liquid escaped and formed a vapour cloud which ignited in explosive manner
