Joelma

Joelma – the building

Joelma – fire timeline

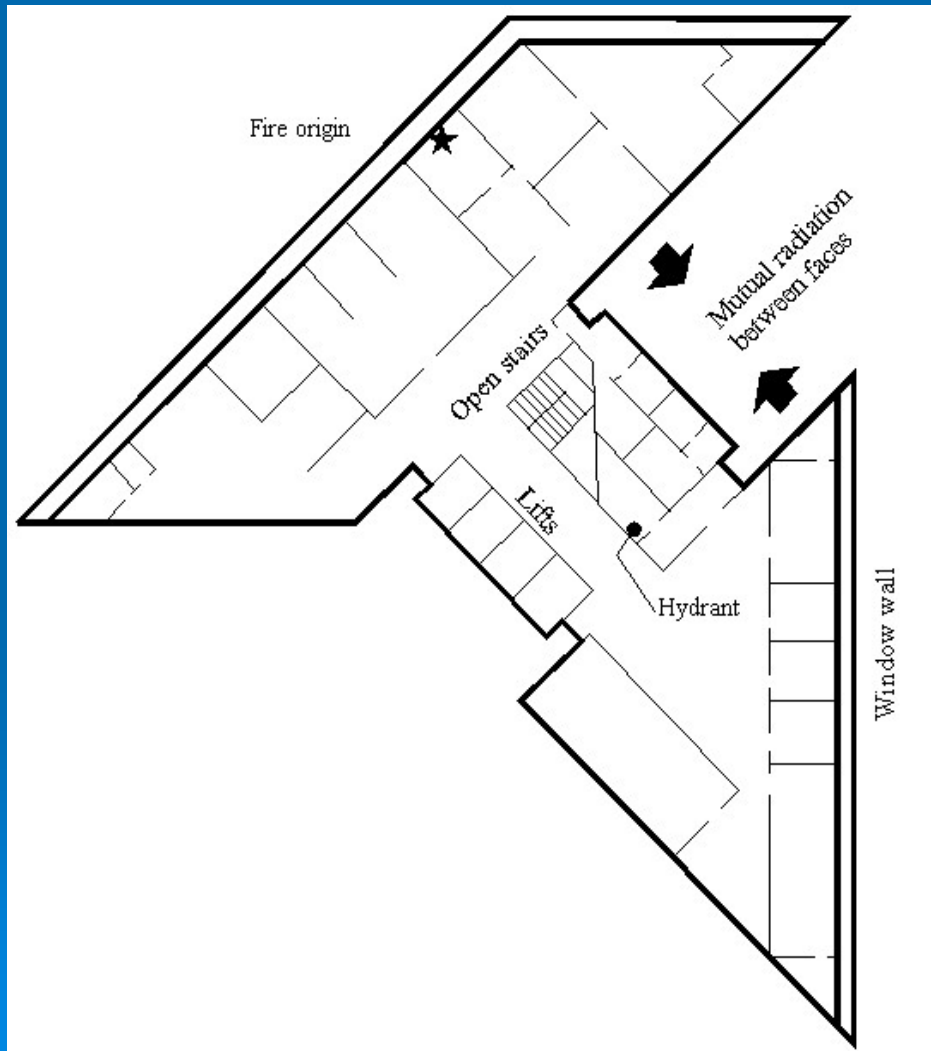
- Joelma plan.
- Note open plan with no protection to stairs and bank of lifts.
- Fire origin shown by asterisk

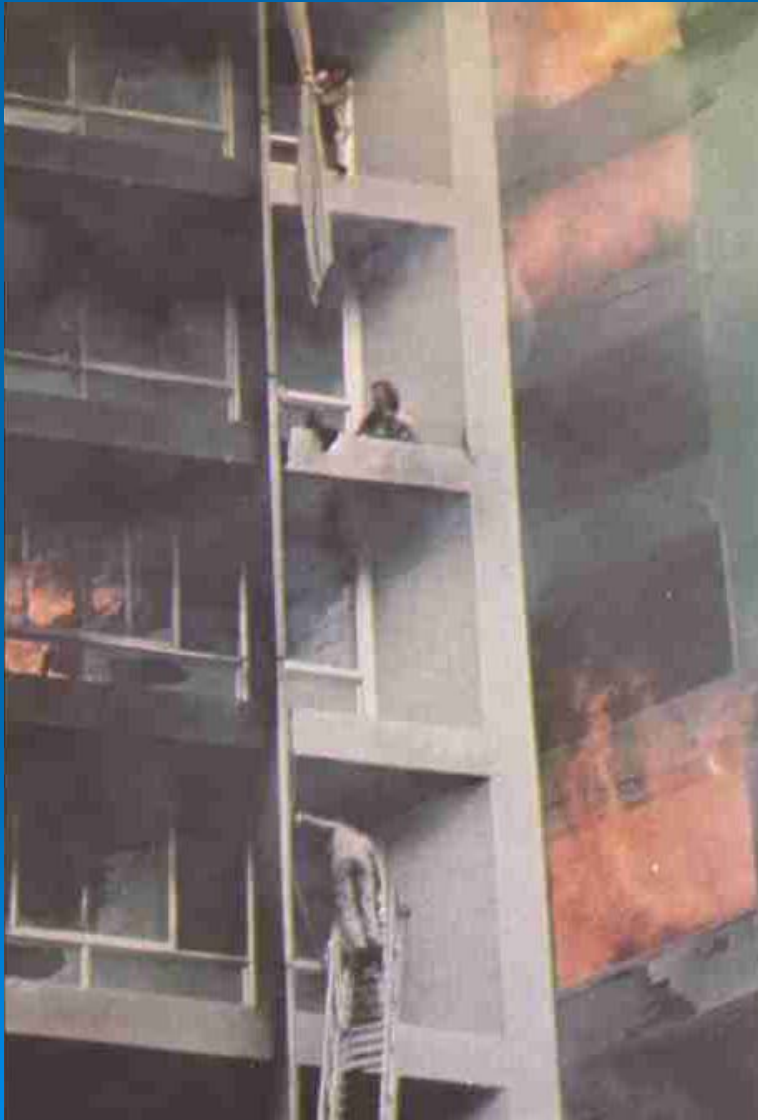
Joelma – balcony protection

- Joelma 3 hours after fire started.
- Many people still waiting to be rescued, protected by the building balcony projections

- Research by BRE concluded a) that a 2 ft horizontal projection between windows in vertically-adjacent storeys is inadequate to prevent flames from a fire entering the upper storey unless fire-resisting glazing is used, and b) that the only sure way to prevent external fire spread would be to omit all windows from the storey immediately above the one with windows.

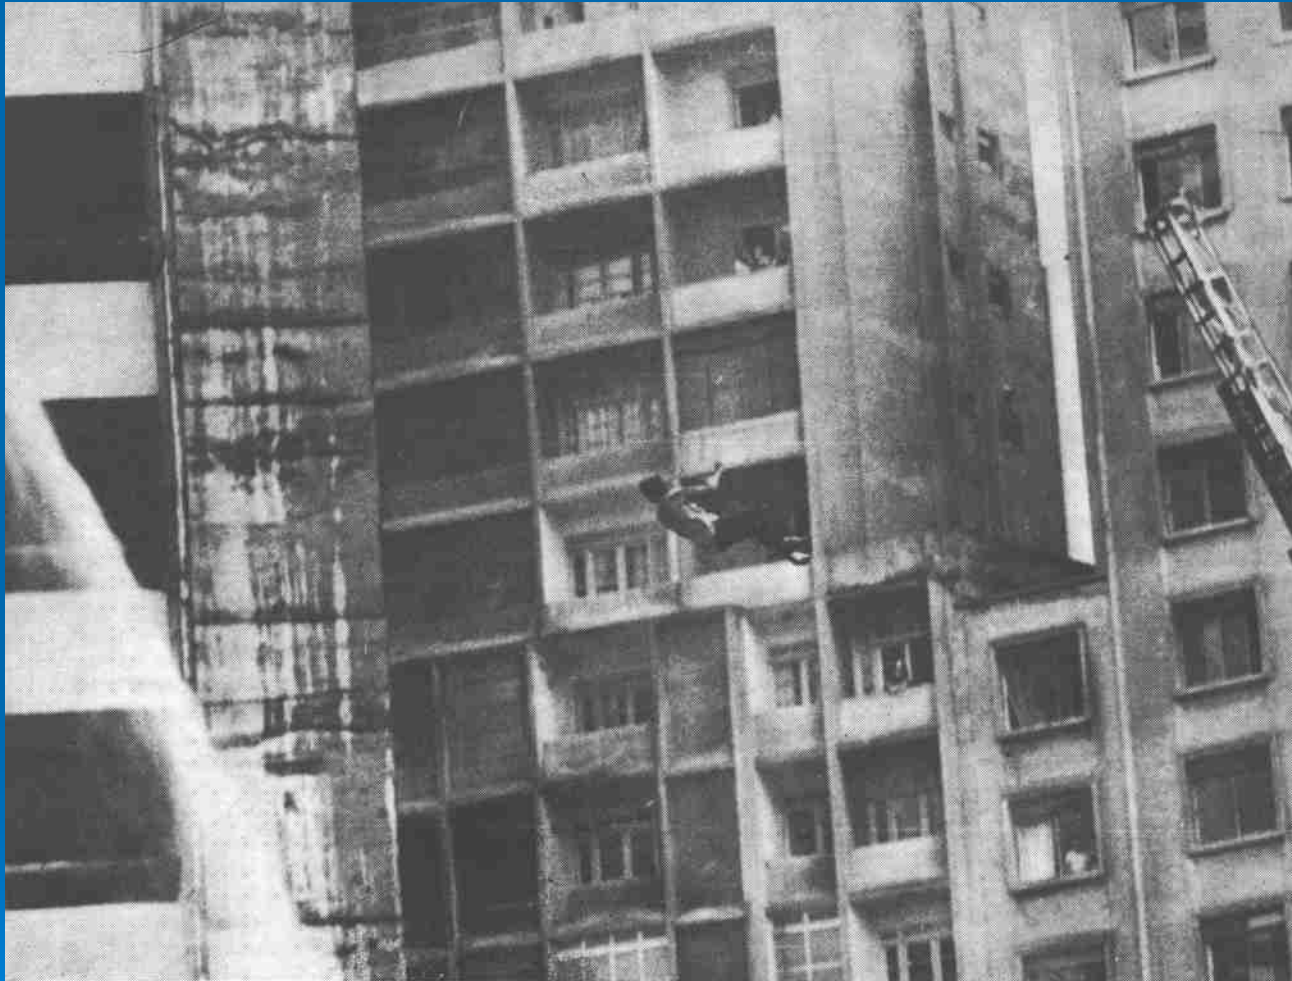
- Person falling after jumping off higher floor (centre of picture).
- Telescopic fire rescue ladder at right

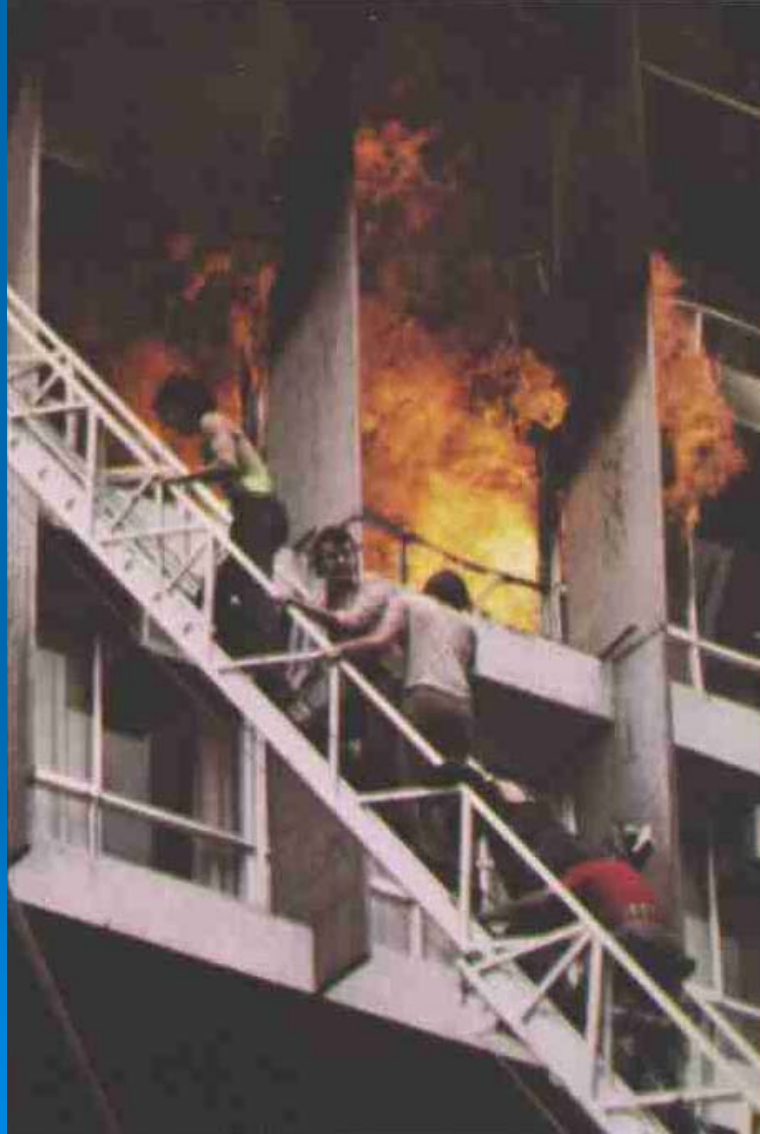
- Many people rescued from high positions by turntable ladders

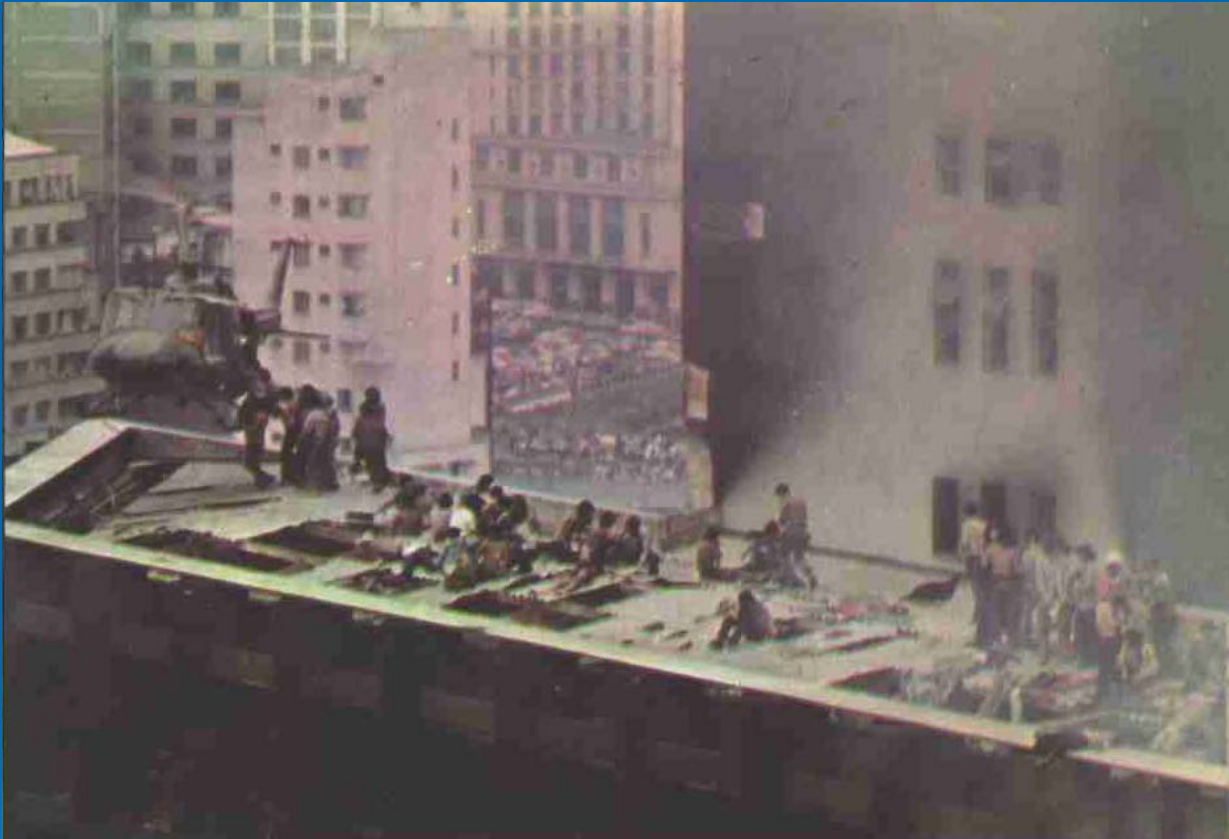
Joelma – rooftop refuge

Some of those who reached the roof died there or jumped.

Survivors were taken off by helicopter

- Some occupants, aware of the successful helicopter rescue from the Andraus building fire two years before, moved up to the roof, but there was no wind to deflect the plume of smoke and hot air and helicopters could not reach many on the roof top in time. The UK policy is to discourage the use of helicopters in this way.
