Joelma

Joelma – the building

Joelma – fire timeline

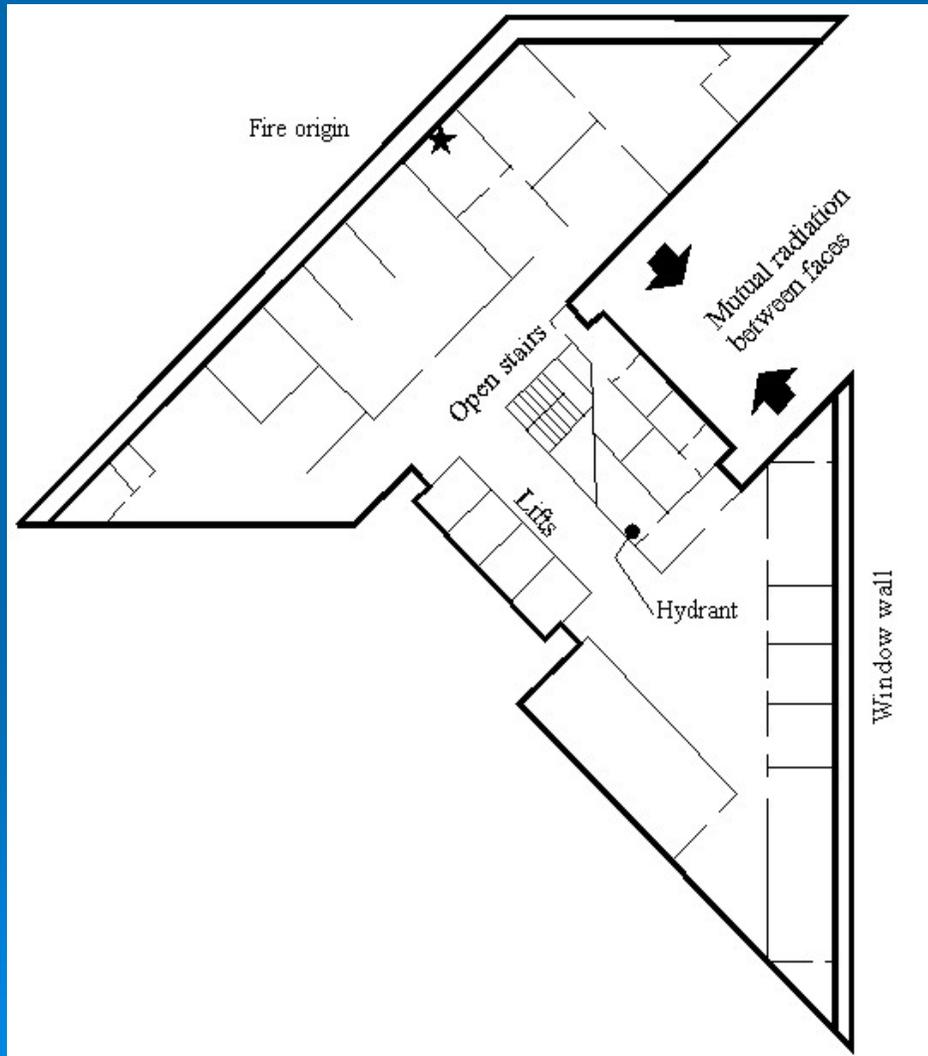
- Joelma plan.
- Note open plan with no protection to stairs and bank of lifts.
- Fire origin shown by asterisk

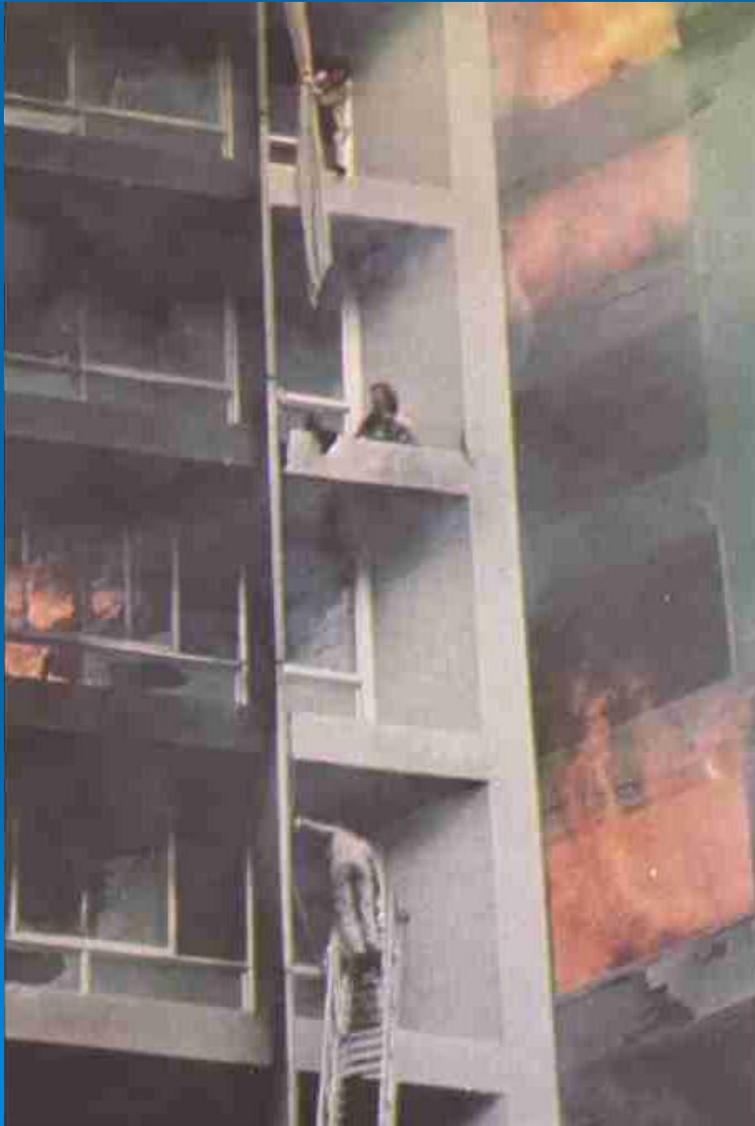
Joelma – balcony protection

- Joelma 3 hours after fire started.
- Many people still waiting to be rescued, protected by the building balcony projections

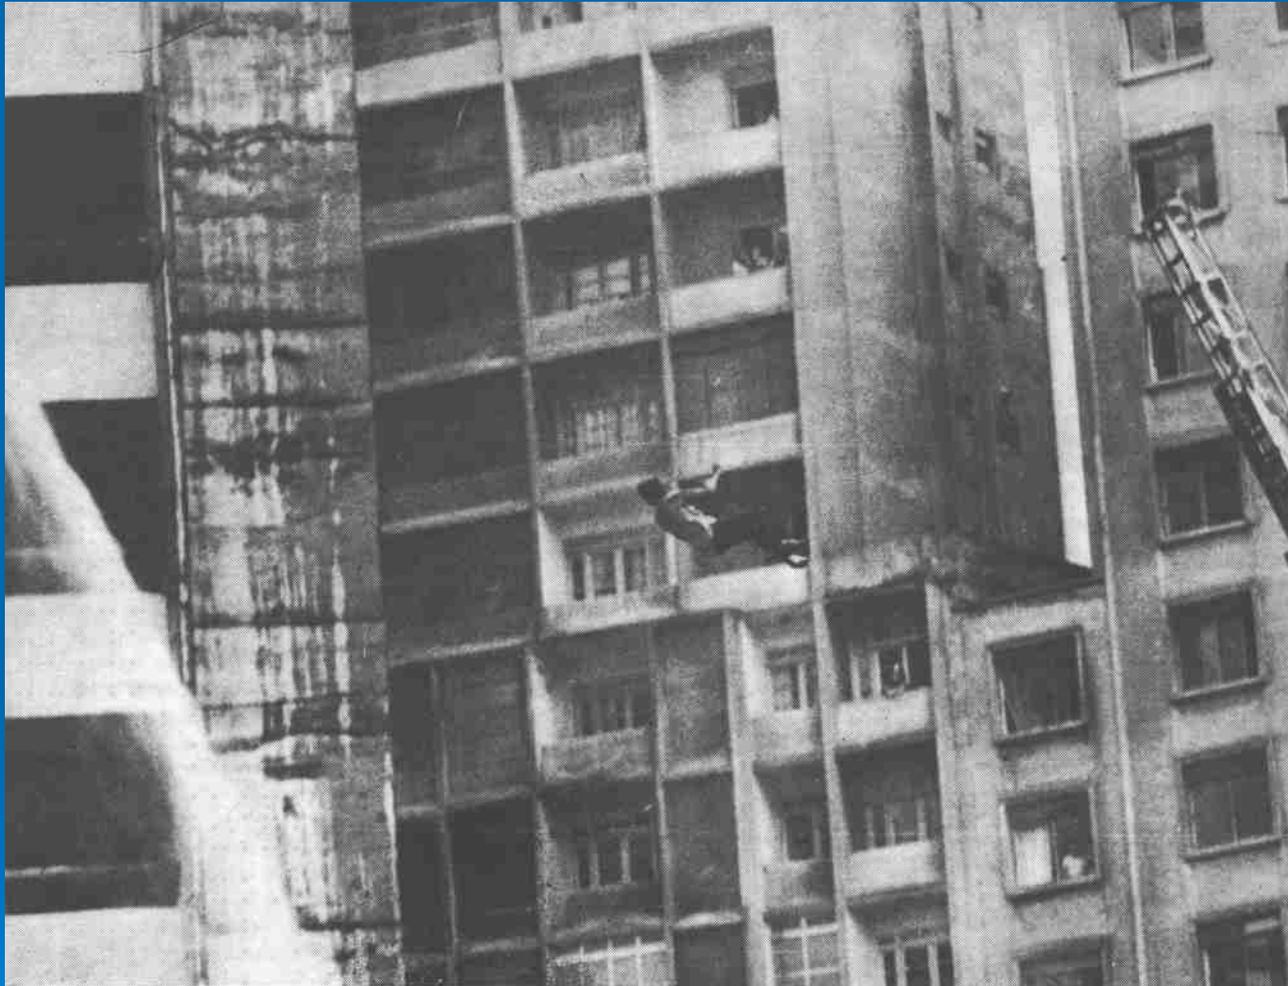
- Person falling after jumping off higher floor (centre of picture).
- Telescopic fire rescue ladder at right

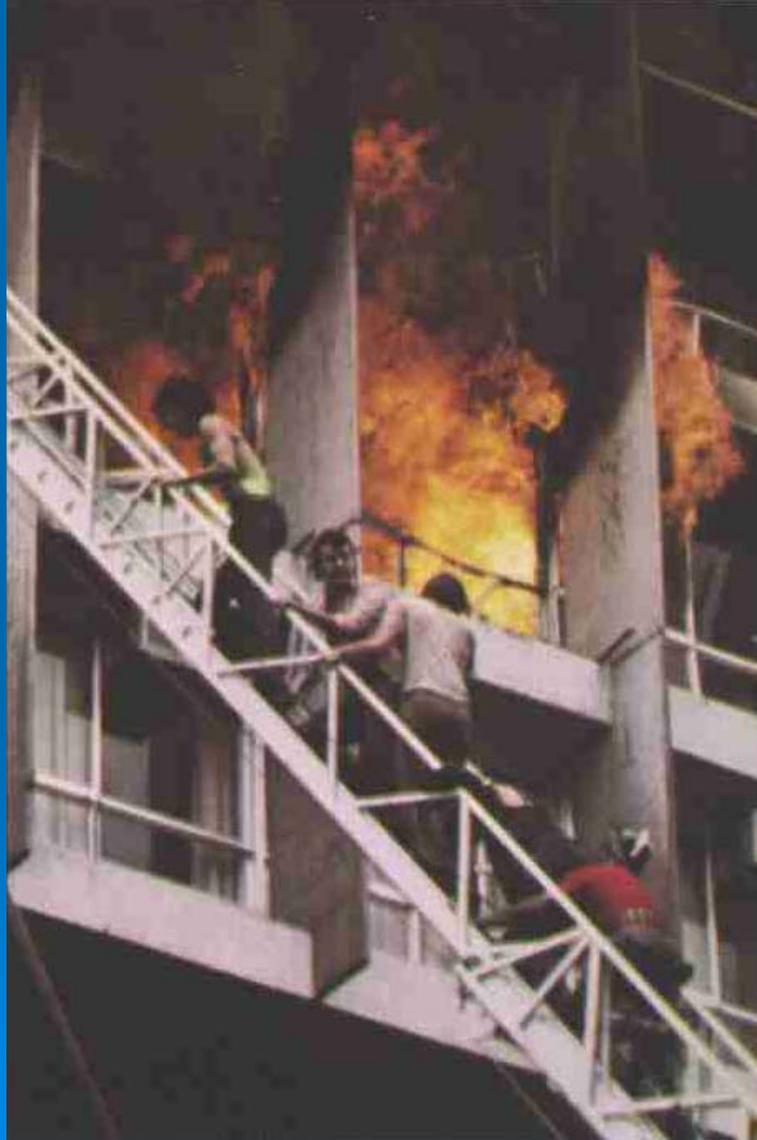
- Many people rescued from high positions by turntable ladders

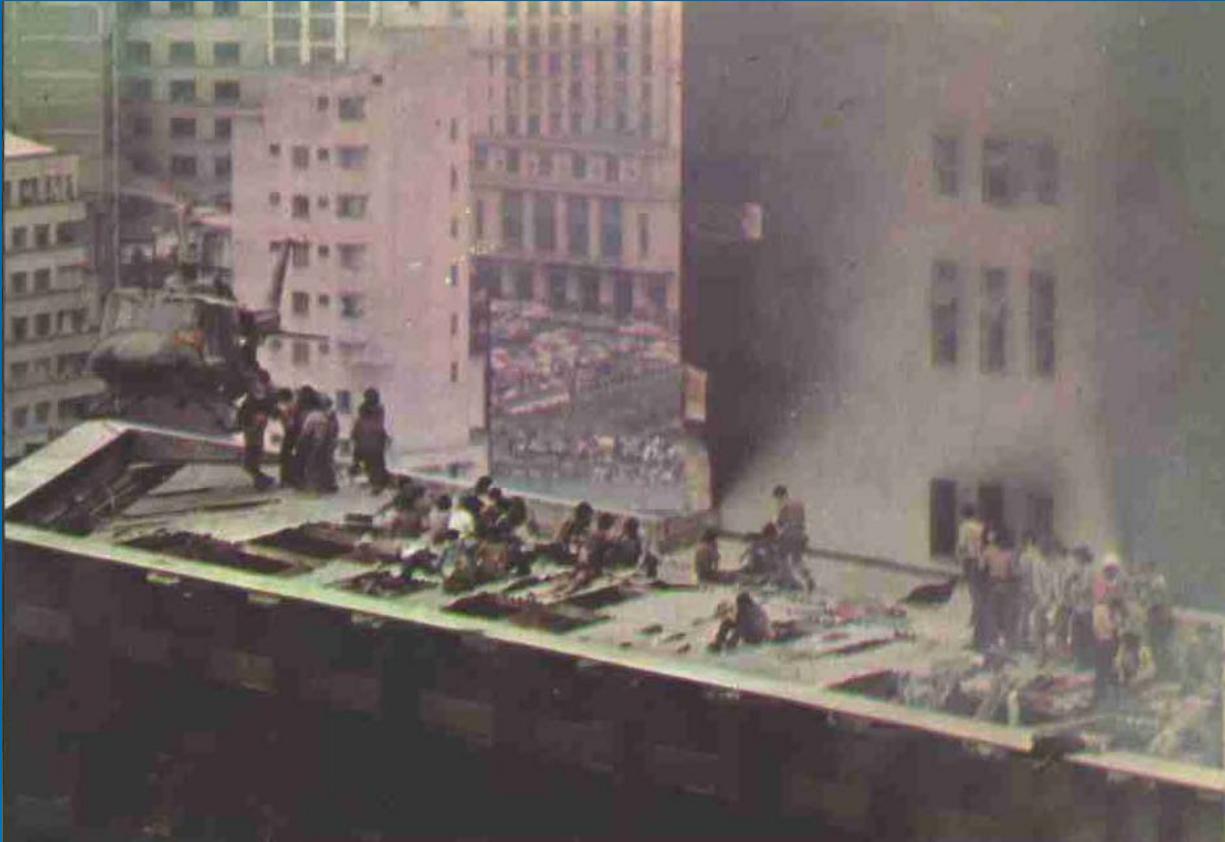
Joelma – rooftop refuge

Some of those who reached the roof died there or jumped.

Survivors were taken off by helicopter
