Ronan Point, Canning Town, London, May 1968

The Incident

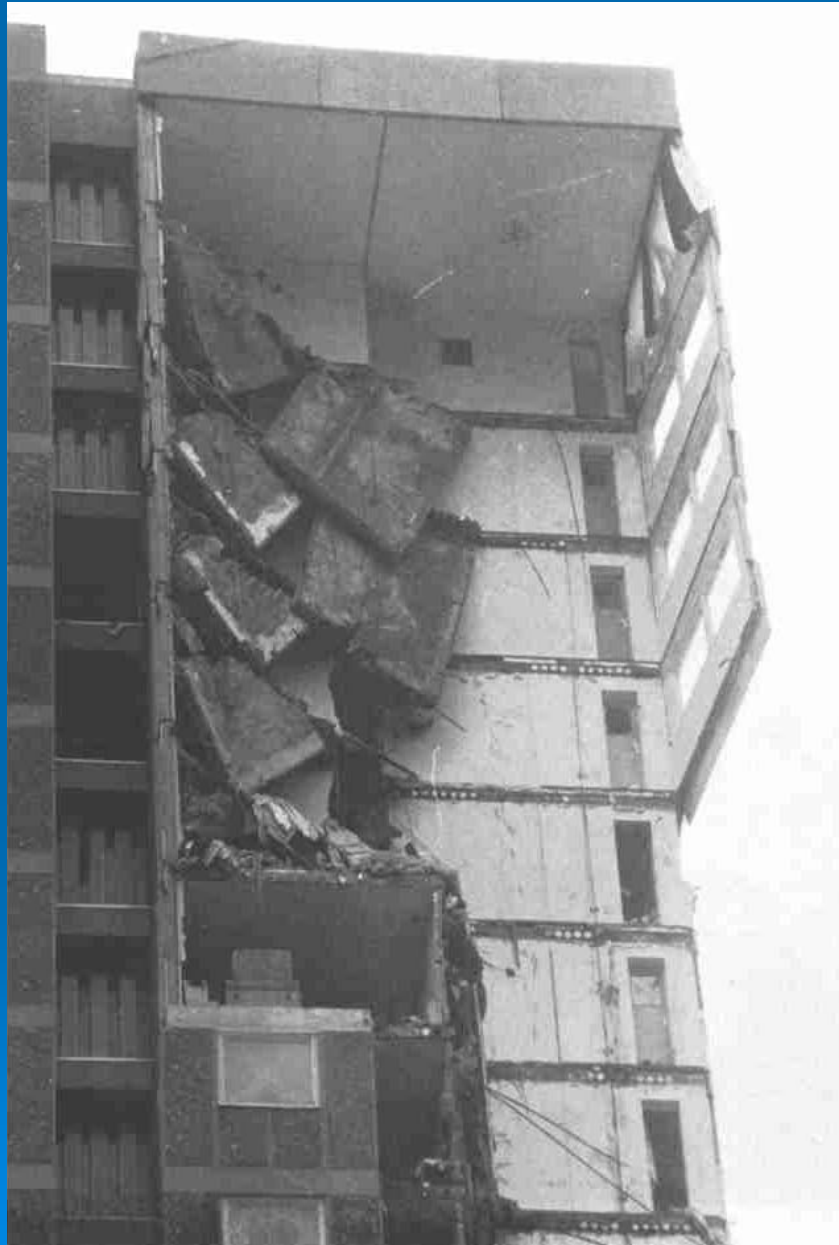
Partial collapse of
Ronan point.

Upper floor panels
have collapsed after
gas explosion blew
out large wall
panels. Floor panels
can be seen
hanging down.

- The cause of the explosion was a broken joint in the connection of the town gas supply to the gas cooker which allowed gas to flow at an estimated rate of 120ft cubed an hour through open doors and accumulate in the flat, and this was ignited when an attempt was made to light the cooker.

- Following the explosion a small fire was caused as gas flowed out of the severed gas supply pipe but this fire was confined to the flat.
- The explosion blew out the internal walls of the flat and also, unfortunately, the load-bearing external flank walls of the living room and bedroom, which left the floor above unsupported and this collapsed.

- The report of the Inquiry showed that:
- the joint between the flank walls and floor was weak and mainly relied on friction and dead load to hold the walls in place

- Following this report the building regulations were amended to provide for structural continuity for buildings above a certain height. All the existing stock of system built high rise buildings were assessed for progressive collapse and modified accordingly, and fire tests were carried out by BRE to examine the instability effects of thermal movement (Cooke and Pigott)

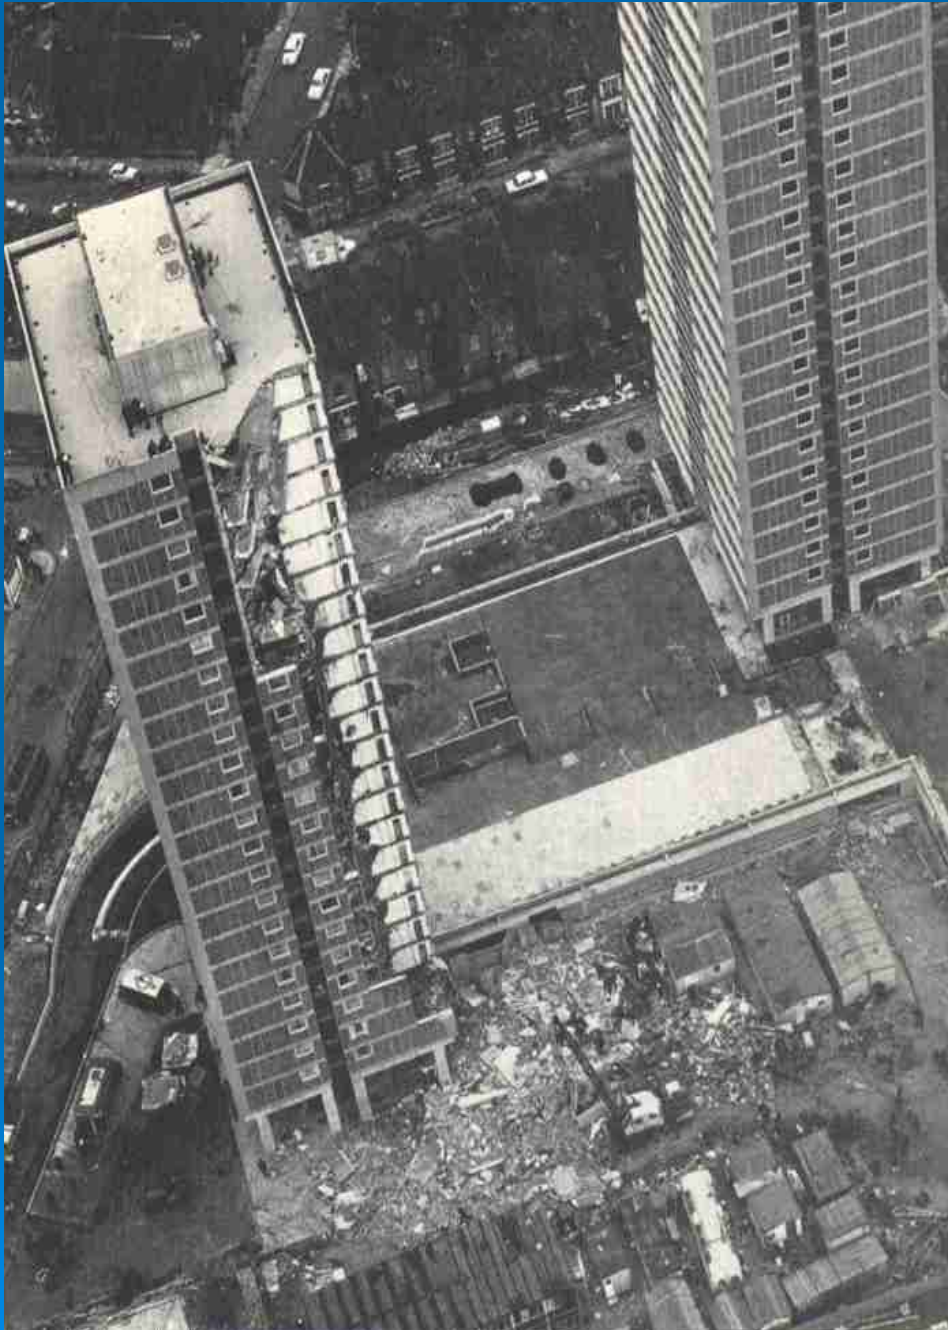
Aerial view of
collapsed corner
of Ronan Point

- The weight of this part of the building as it fell caused a progressive collapse of the sitting rooms in the remainder of the south-east corner down to podium level. Mercifully most tenants were still in their bedrooms at the time of the explosion; only the sitting room floors collapsed.
