# *Star Princess* cruise ship, 2006

## *Star Princess – the fire*

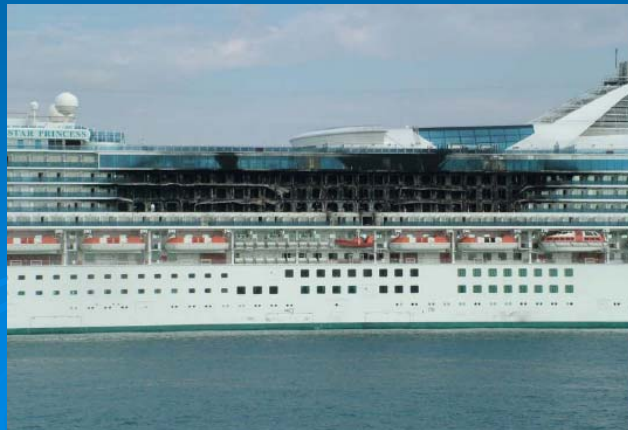
- The fire was extinguished about 1.5 hours after it had started. The crew fought the fire with water hoses from adjacent external areas, and from internal alleyways.
- Difficulty was experienced in reaching the fire due to the construction and partitioning of the balcony areas.
- 79 cabins were condemned after the fire, and a further 204 were either water or smoke damaged.
- The damaged area covered 3 vertical fire zones on 5 decks as shown below

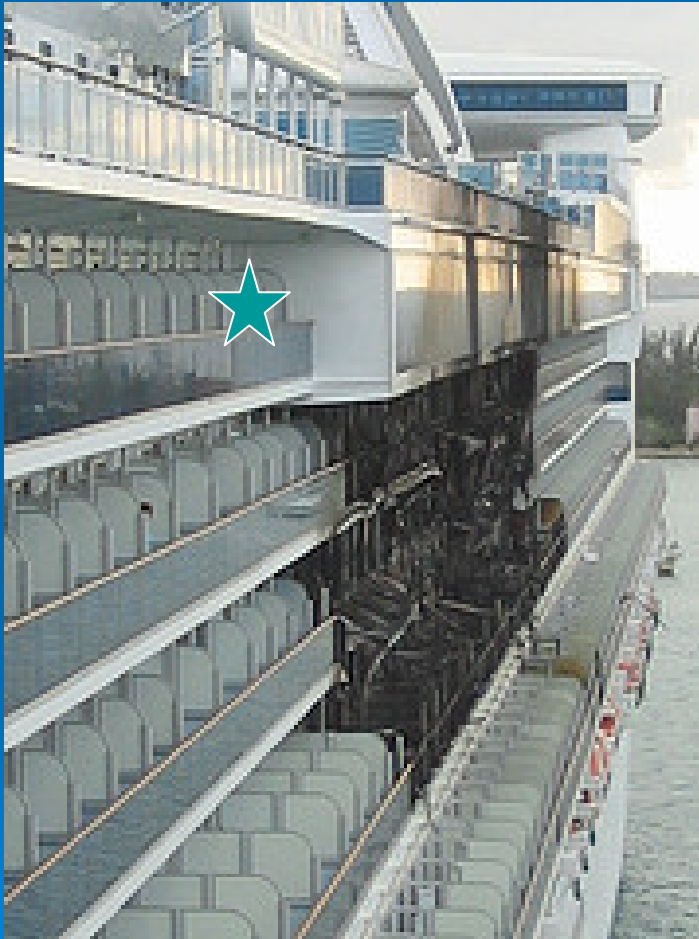
# Star Princess – plastic balcony dividers

- The seat of the fire was on an external stateroom balcony sited on deck 10 on the vessel's port side.
- The fire spread rapidly along adjacent balconies, and within 10 minutes had spread up to decks 11 & 12 and onto stateroom balconies in two adjacent fire zones.
- The fire also spread internally as the heat of the fire shattered the glass in stateroom balcony doors, but was contained by the fixed fire suppression system fitted in each of the staterooms.
- As the fire progressed, large amounts of dense black smoke were generated from the combustible materials on the balconies, and the polycarbonate balcony partitions.

- The vertical balcony dividers can be seen to right of green asterisk
- In the 3 lower deck levels these dividers have been consumed by fire (the blackened area)

- Plastic sheet balcony dividers should be replaced with dividers of non-combustible material.
- Increased vigilance is necessary and review of crew's on board fire fighting response needs to be reviewed.
- Passengers and crew should be advised not to leave towels and personal belongings on balconies when they are not in their rooms.
- Passengers should be reminded a) not to throw any items over a ship's side from balconies or other external areas and b) not to use unauthorized heating elements such as electrical heating coils used in cups or mugs and open flames such as candles.

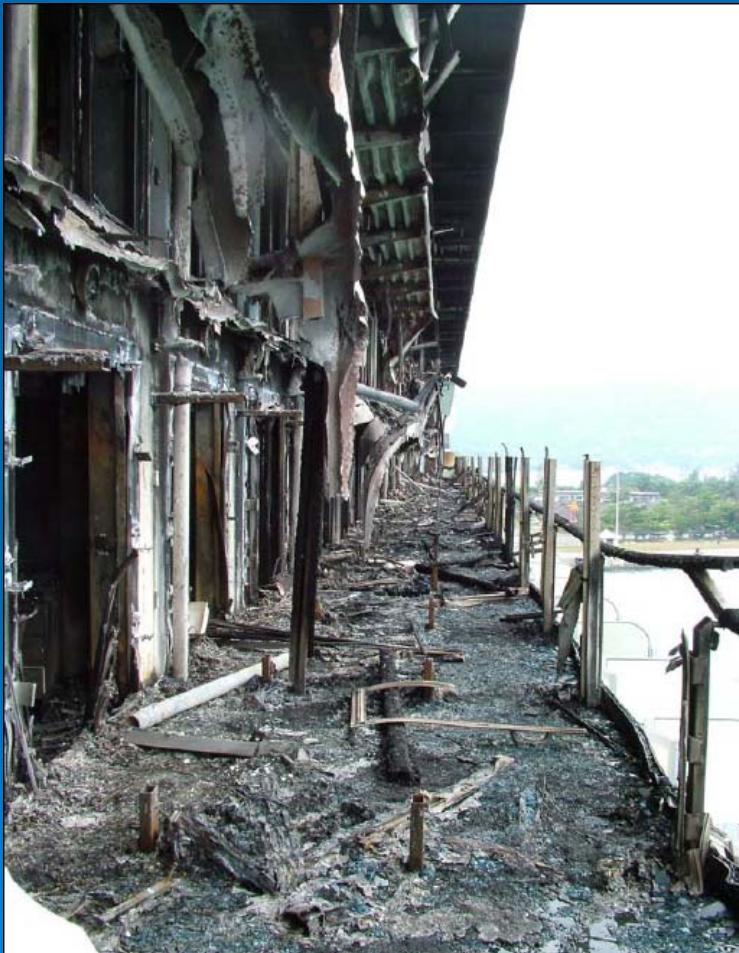
left – view of fire damaged balcony (dividers have vanished in fire)

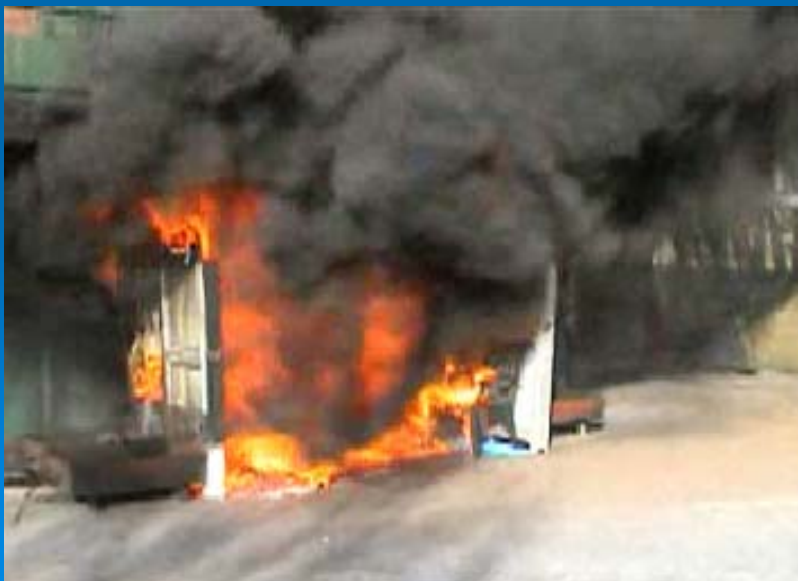
ad hoc fire test

- Fire tests showed that polycarbonate balcony divisions generated intense heat and copious amounts of dense black smoke as they burned
- SOLAS regulations do not, currently, control the combustibility of materials used on external balcony areas, as these are not included within the vessel's fire zones.
- Similarly, balcony areas on cruise ships are not required to have fixed fire detection or suppression systems, as would be the case in internal areas.
