Summerland leisure centre, Isle of Man, August 1973

Summerland – building data

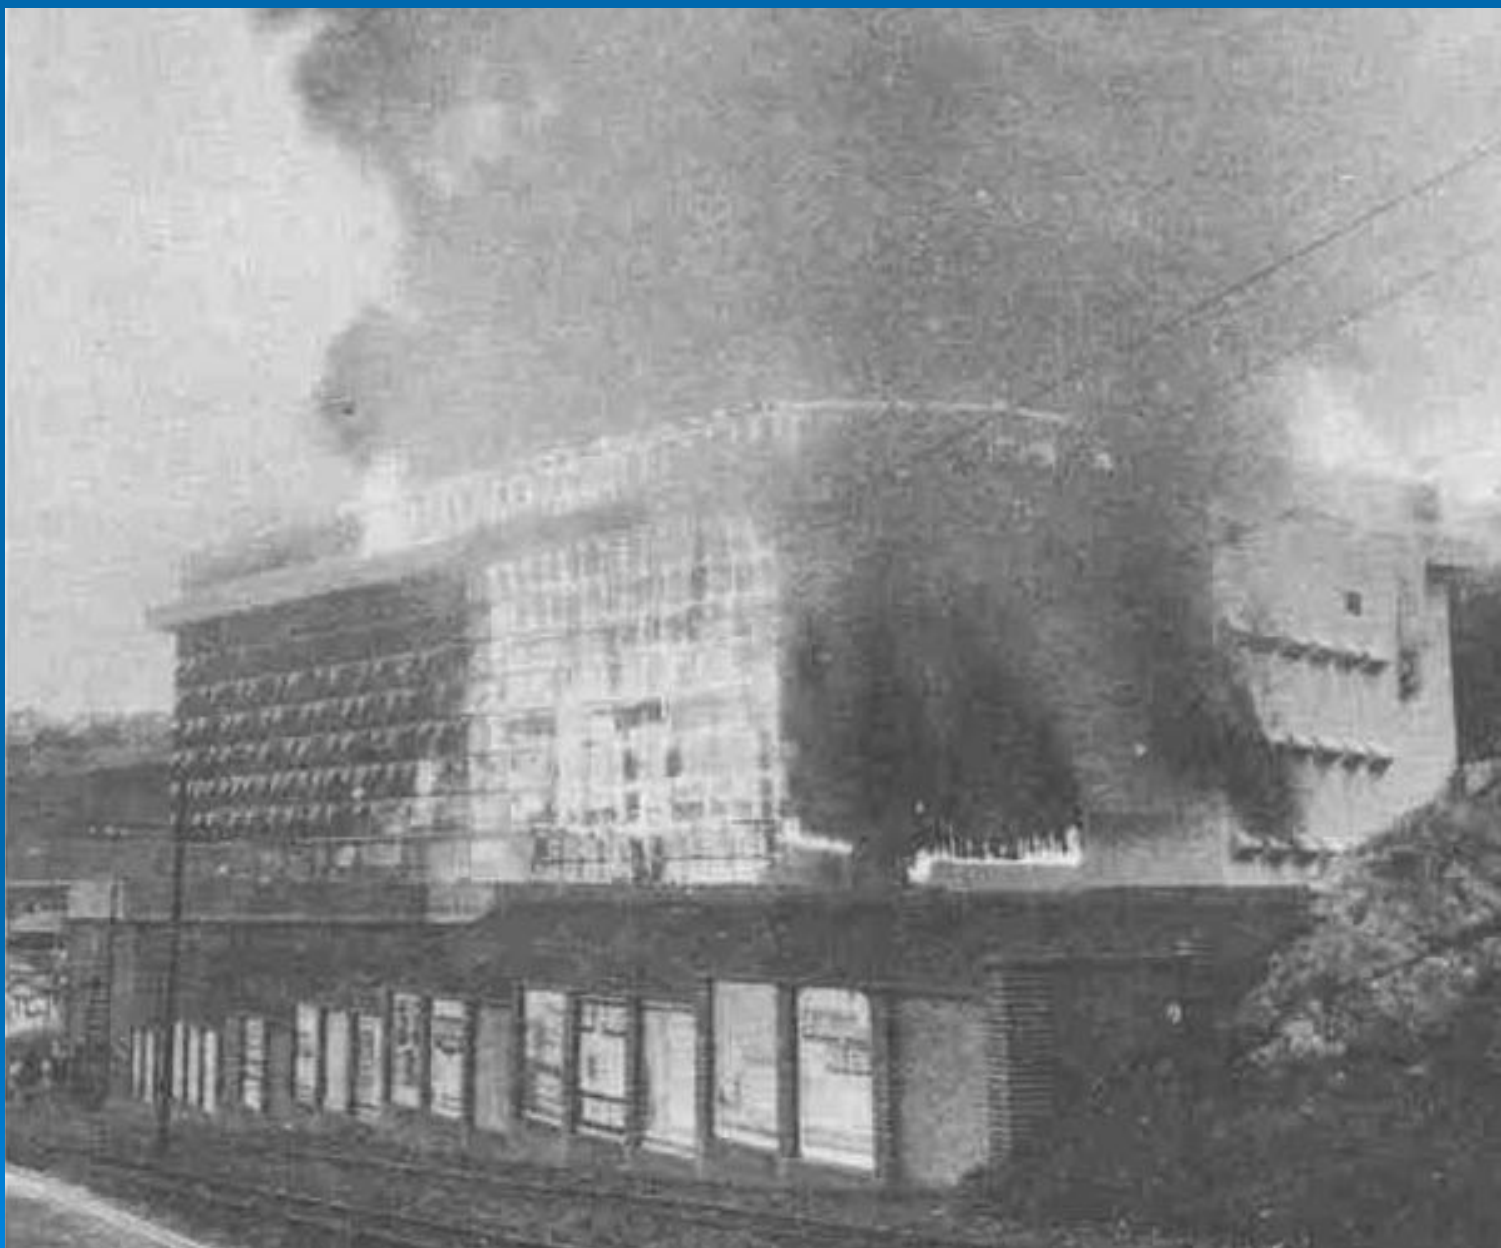
- Summerland fire in progress. Note steep rising land on one side making access difficult for the fire brigade

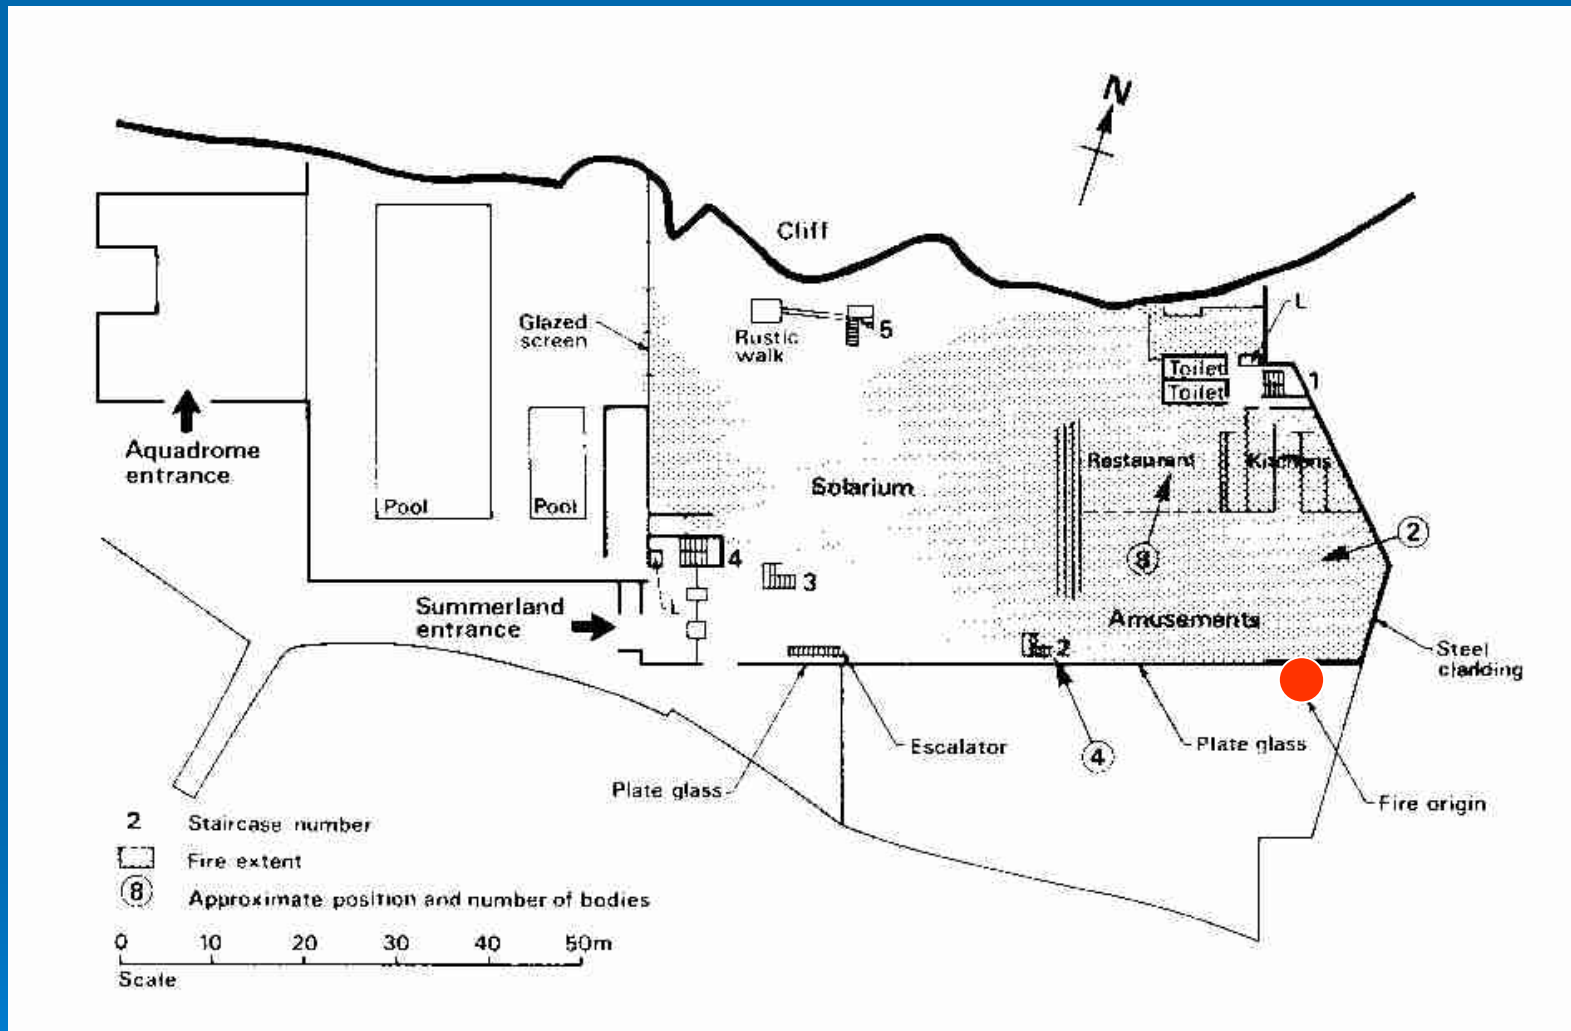
- Summerland fire in progress. Note steep rising land on one side
- Position and number of bodies shown ringed.

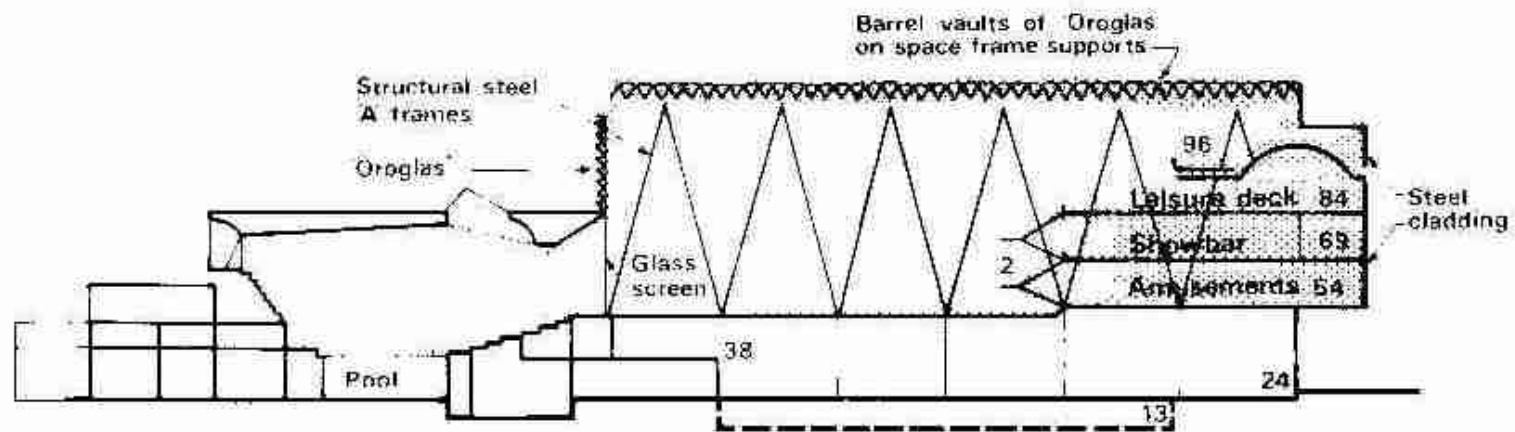
Fire extent

- Vertical section showing fire affected area (shaded) at RHS
