# Woolworth's retail store, Manchester, May 1979

10 deaths due to smoke inhalation

# Woolworth's – building plan

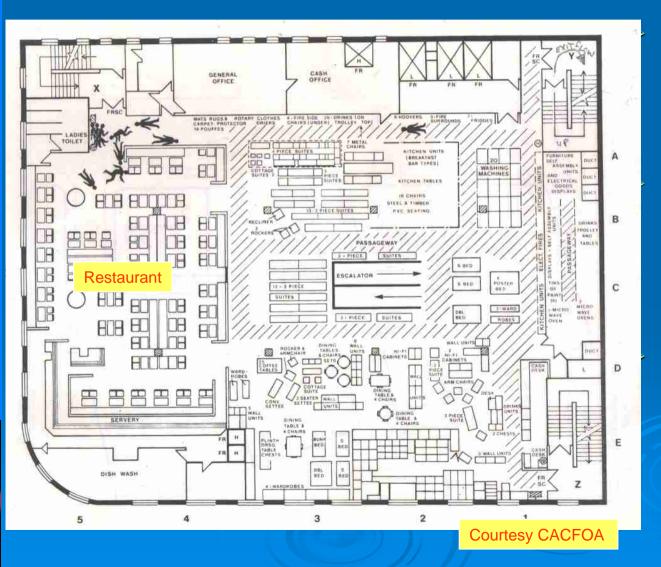
First floor plan shows location of bodies surprisingly close to escape stair.

Note restaurant centre left, escalator in centre and 3 well-positioned escape stairs.

Too much furniture on display - most should have been in a fire resisting room.

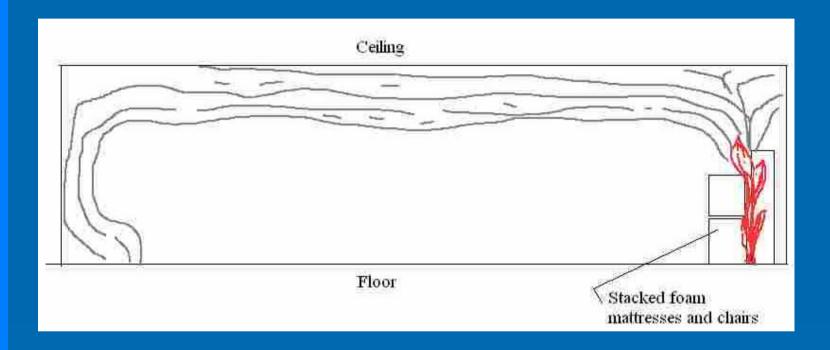
It is thought that fire spread was so rapid and the polyurethane (PU) fire gases were so lethal that people close to the floor exits could not get out in time.

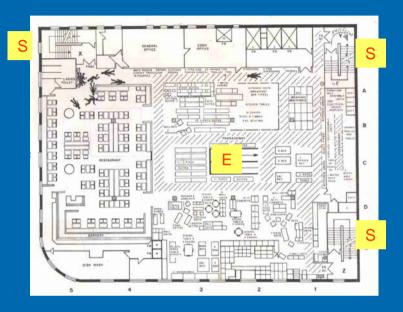
- The store was built in 1929 and comprised 8 floors including 2 basements. It was 42 m x 35 m in plan and was steel framed with concrete floors and concrete stairways.
- > The stairways (S) were well positioned for means of escape. A centrally placed escalator (E) communicated with several floors.

- The building was equipped with a mains-fed fire alarm having alarm bells and break-call points on each floor.
- > The self service restaurant on the second floor could seat 208 people but at the time of the fire there were 70 to 100 people on the floor of the store.
- The shop operated without a fire certificate required under the legislation, though slow progress was being made to get one.
- At the time, the legislation did not require upholstered furniture to have a low flammability - this was required later in 1980.
- There were no sprinklers and none were required for life safety purposes.
