The Tally Ho building complex and its fire precautions

by Gordon Cooke

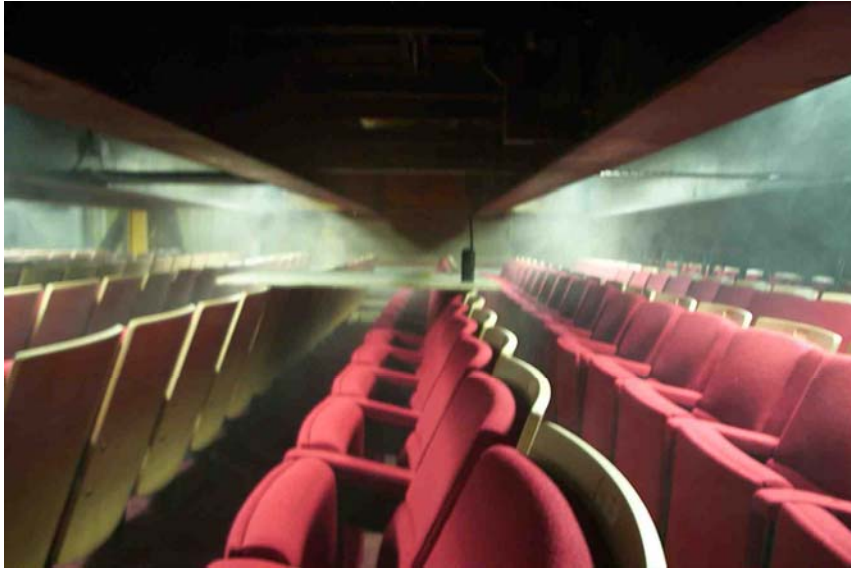
same level) has been treated in the factory to give Class O. In this way it is unlikely that a fire will occur in the seat store and, if it does, it will be detected early on, permitting evacuation of occupants of the theatre above at a very early stage in fire development. The edge of the moving floor has nylon brush seals around all four edges to seal against smoke passage. It should be noted that the seat store is only separated from the theatre auditorium above when the floor is in flat mode and thus the floor edge seal will only be fully effective in this mode, but the aspirating smoke detection will be operational for all modes (raising/lowering/tilting) of floor use.

Seat store with smoke test on VESDA aspirating detection system in progress. Small fire is in bin resting on board on top of seats (centre of picture)

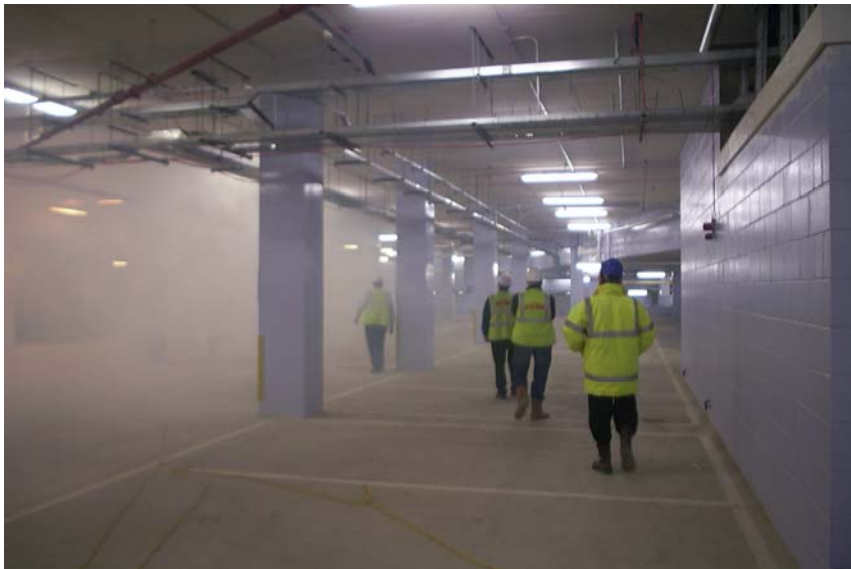
Cold smoke tests have been done in my presence using a smoke-making machine in different areas in the two storey parking area and I was satisfied with the results in terms of direction and rate of smoke clearance. Upon arrival the fire service can control the fans. There are three well-positioned dry risers which serve the car park levels for fire fighting purposes

Smoke test in basement car park. Picture shows smoke logging before smoke control fans switched on.

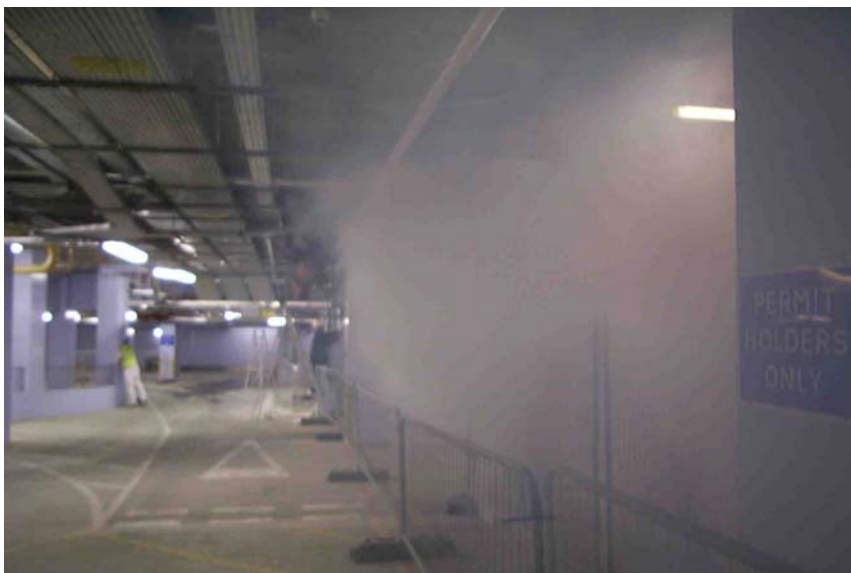
Part of smoke 'corridor' formed by PSB jet fans after they were switched on by detection system.

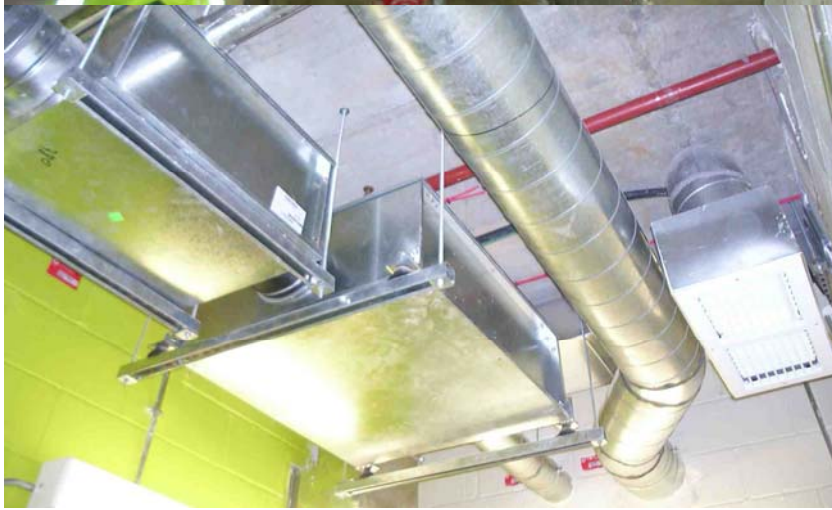
Exposed air
handling plant
on soffit in
Community
Focus

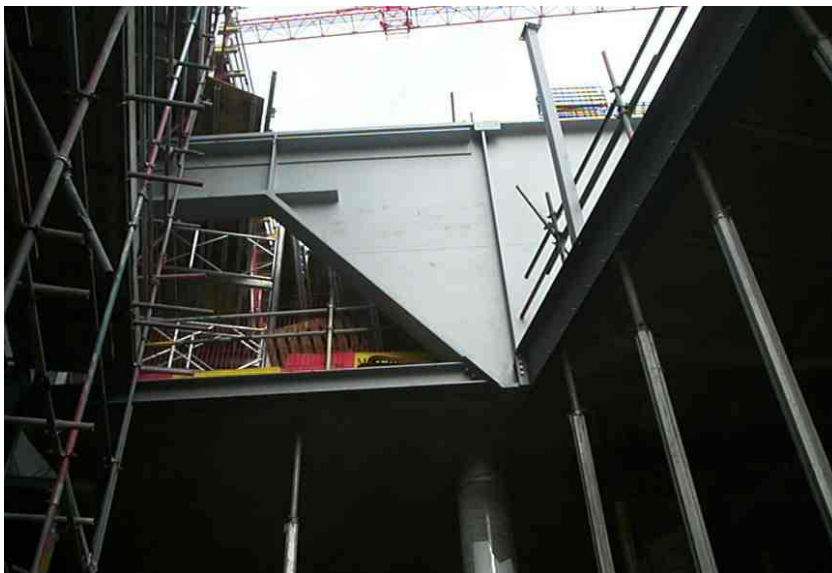
The roof to the auditorium is a grid of diagonally-braced steel girders and they are unprotected. Similarly, the technical gallery above the auditorium is also unprotected but has good means of escape. There is a massive, concealed, storey-high steel girder in the Arts centre and this is provided with 2hr fire resistance by enclosing concrete blockwork and with intumescent paint on some exposed small steel areas.

Part of
massive
storey-high
steel plate
girder acting as
load transfer
structure in the
Arts Centre

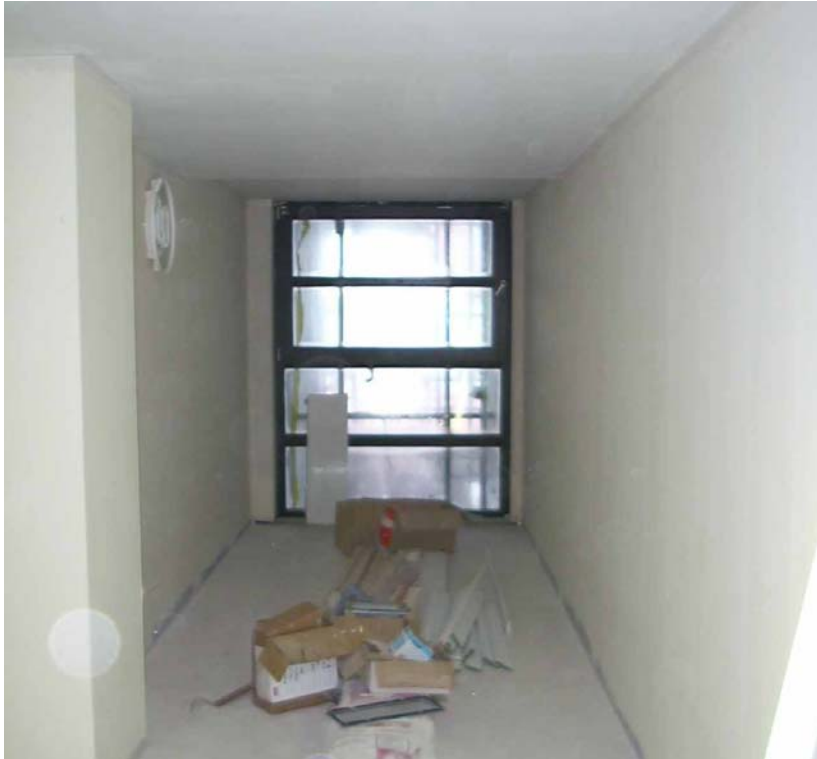
Cross-corridor
smoke
ventilating
window in
residential
tower block
during
construction
