Paper presented at the International Symposium on Protection of Cultural Heritage Buildings from Fire, Kyoto, Japan, April 6 – 7, 2003

UPGRADING THE FIRE RESISTANCE OF FLOORS AND DOORS IN HERITAGE BUILDINGS

Gordon Cooke BSc PhD CEng MIMechE MICE FIFireE

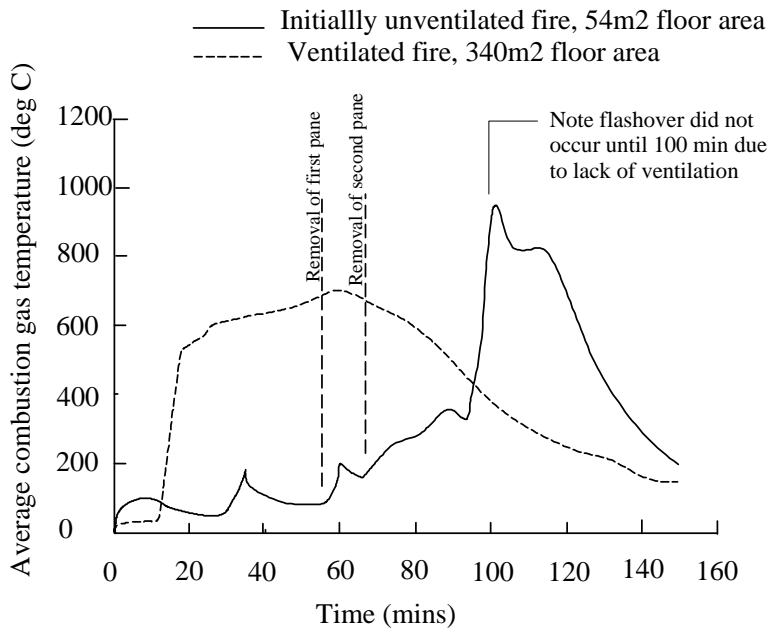
Figure 2 Typical fire development history showing effect of ventilation on combustion gas temperature

Fire resistance only becomes important when the fire becomes fully developed. Figure 2 shows two real fire development histories, each involving a growth phase, a fully developed phase and a decay phase. The curves differ mainly because of different ventilation conditions. The curves, the results of large compartment fire tests conducted by BRE in the UK, show that in a compartment with office type fire load it is possible for flashover to be delayed by keeping all openings closed – in the test curve for the smaller compartment, panes of glass had to be removed to encourage the fire to develop. Hence closing doors and other ventilation openings not only prevents smoke damage beyond the room of fire origin but can also prevent the fire reaching flashover within the room of origin. This is important for heritage buildings.

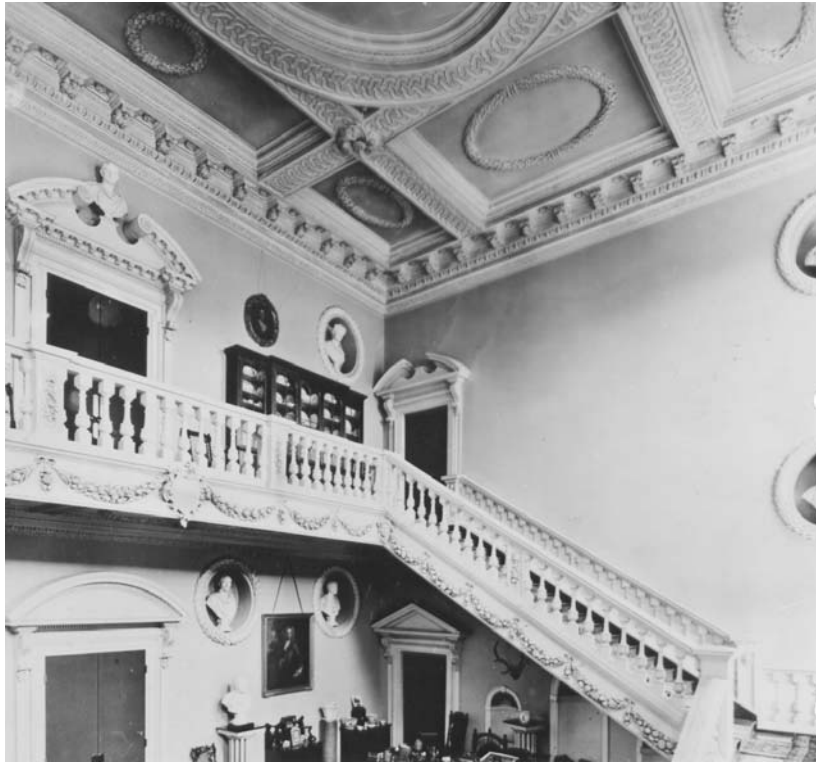
Figure 4 Example of ceiling which cannot be fire protected from below.

Figure 4 shows part of a historic ceiling. It would clearly be unacceptable to add a fire-protecting layer to the bottom of such a ceiling, but if access into the floor from above is possible the fire resistance can be improved in several ways, as demonstrated below.

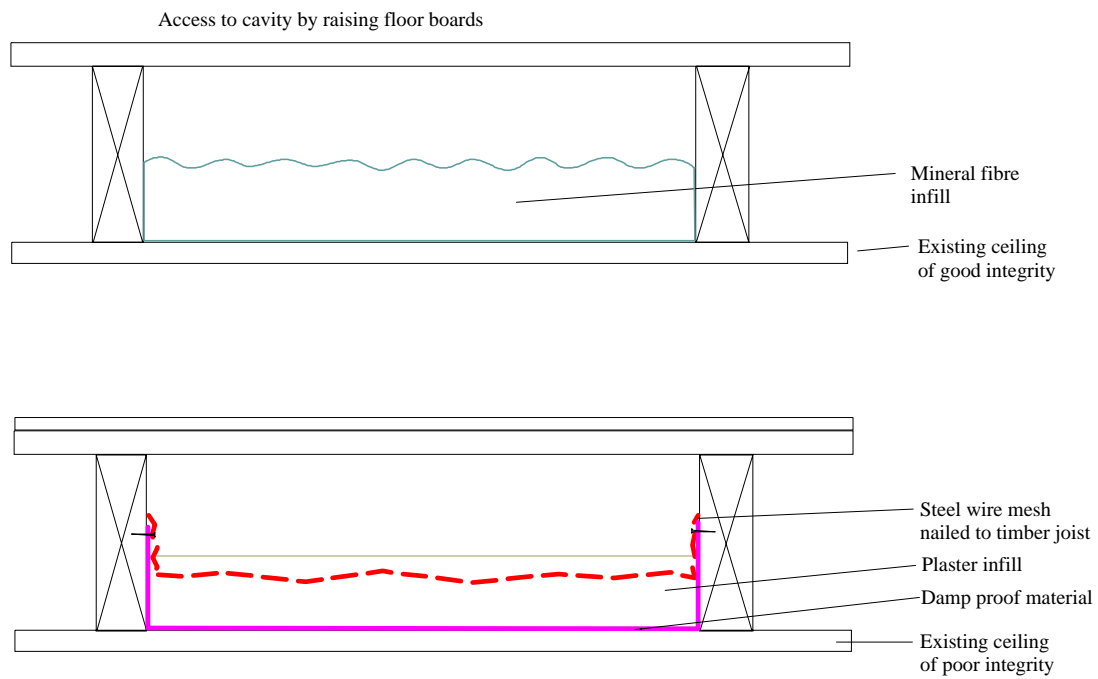
Figure 6 Floor upgraded with partial filling of mineral fibre or lightweight plaster

If the ceiling is in good condition and unlikely to fall down early in fire, the fire resistance may be improved by placing rock wool in the cavity, Figure 6.

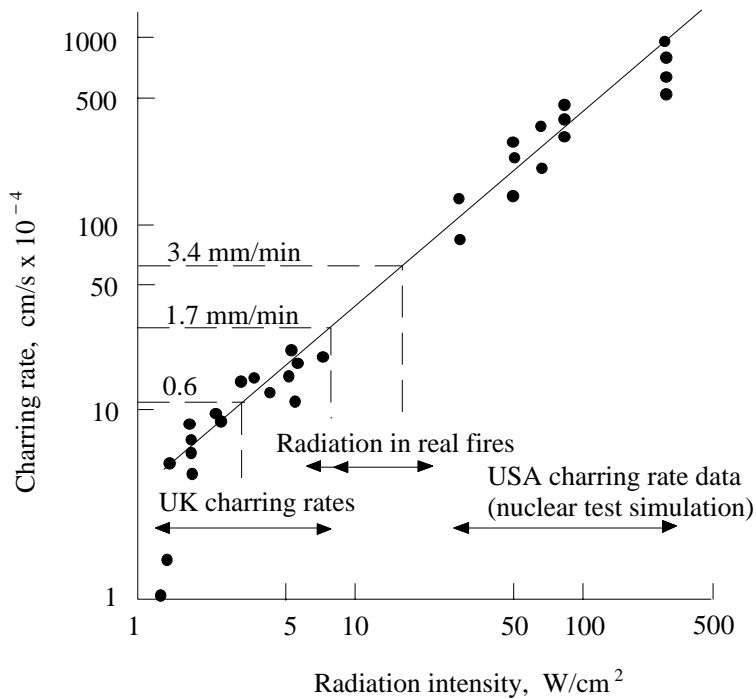
Figure 9 Charring rate of timber versus radiation intensity

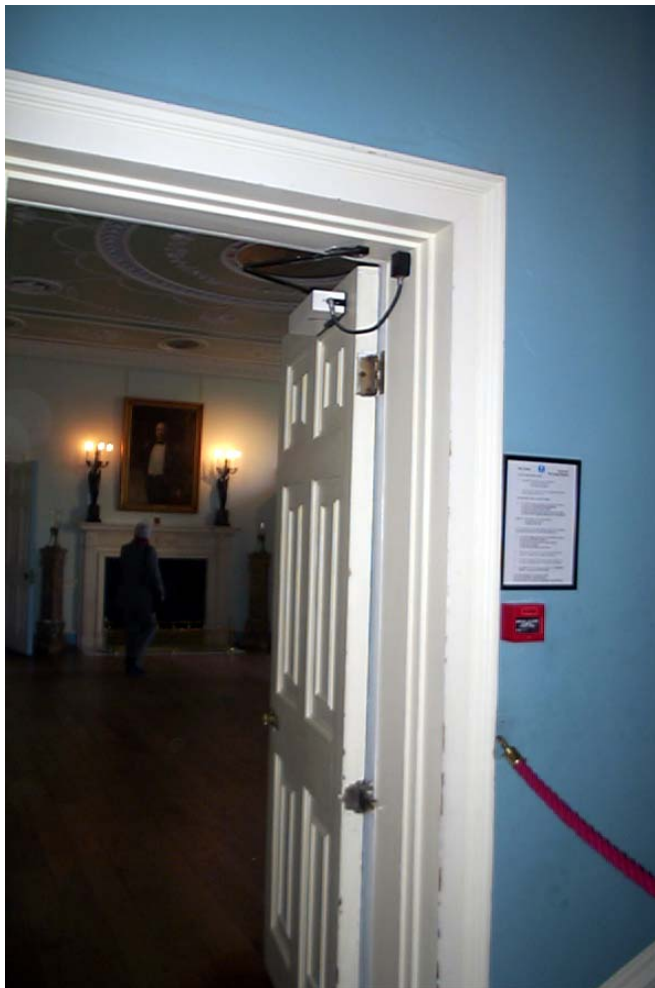
Figure 13 Fire door with hold-open device released by fire detection

Doorways are potential routes of fire spread. There is little advantage in having a fire-resisting door set (door and its frame) if the door is left open during a fire. This can be prevented by having electrically released door hold-open devices, Figure 13, actuated by fire detection. Panels above doors should be checked for fire resistance, and the presence of a glazed panel should be carefully considered, Figure 14. Radiation through the glazed area may be acceptable if transmitted radiation cannot ignite materials on the other side, and this can be calculated. If the level of incident radiation on combustible objects or finishes near the unexposed face is unacceptable then an intumescent/glass laminate may be used, if the greater thickness and weight can be tolerated.

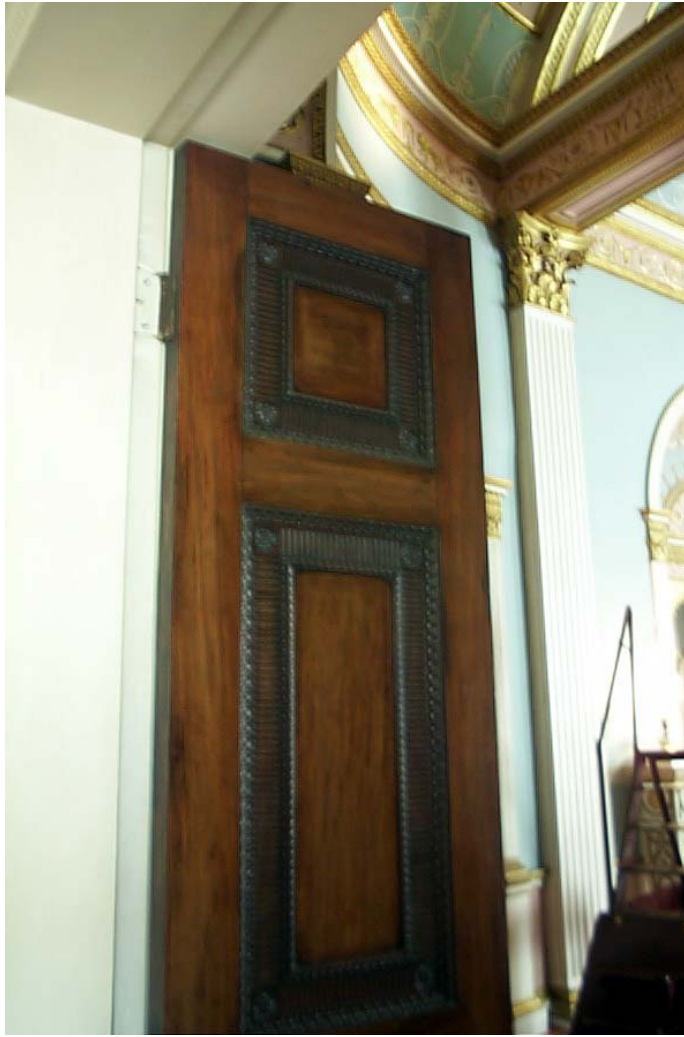
Figure 18 Mahogany door with moulded panels

Historic doors often have panels which are thinner than the frame which holds them in place, Figure 18. The fire integrity of a door is usually weakest at the panel edges,
