Gothenburg dance hall, Sweden, 1998

- The fire occurred on 28 October 1998 in a crowded dance hall in Gothenburg.
- 63 people died, 120 were injured and about 60 were rescued by the fire brigade.
- The hall had about 400 people present at the time of the fire but it was only authorised for 150 people by the local fire chief.
- The fire started in chairs which had been stored in one of the two escape staircases.
- Four young boys were convicted of murder one and a half years after the fire

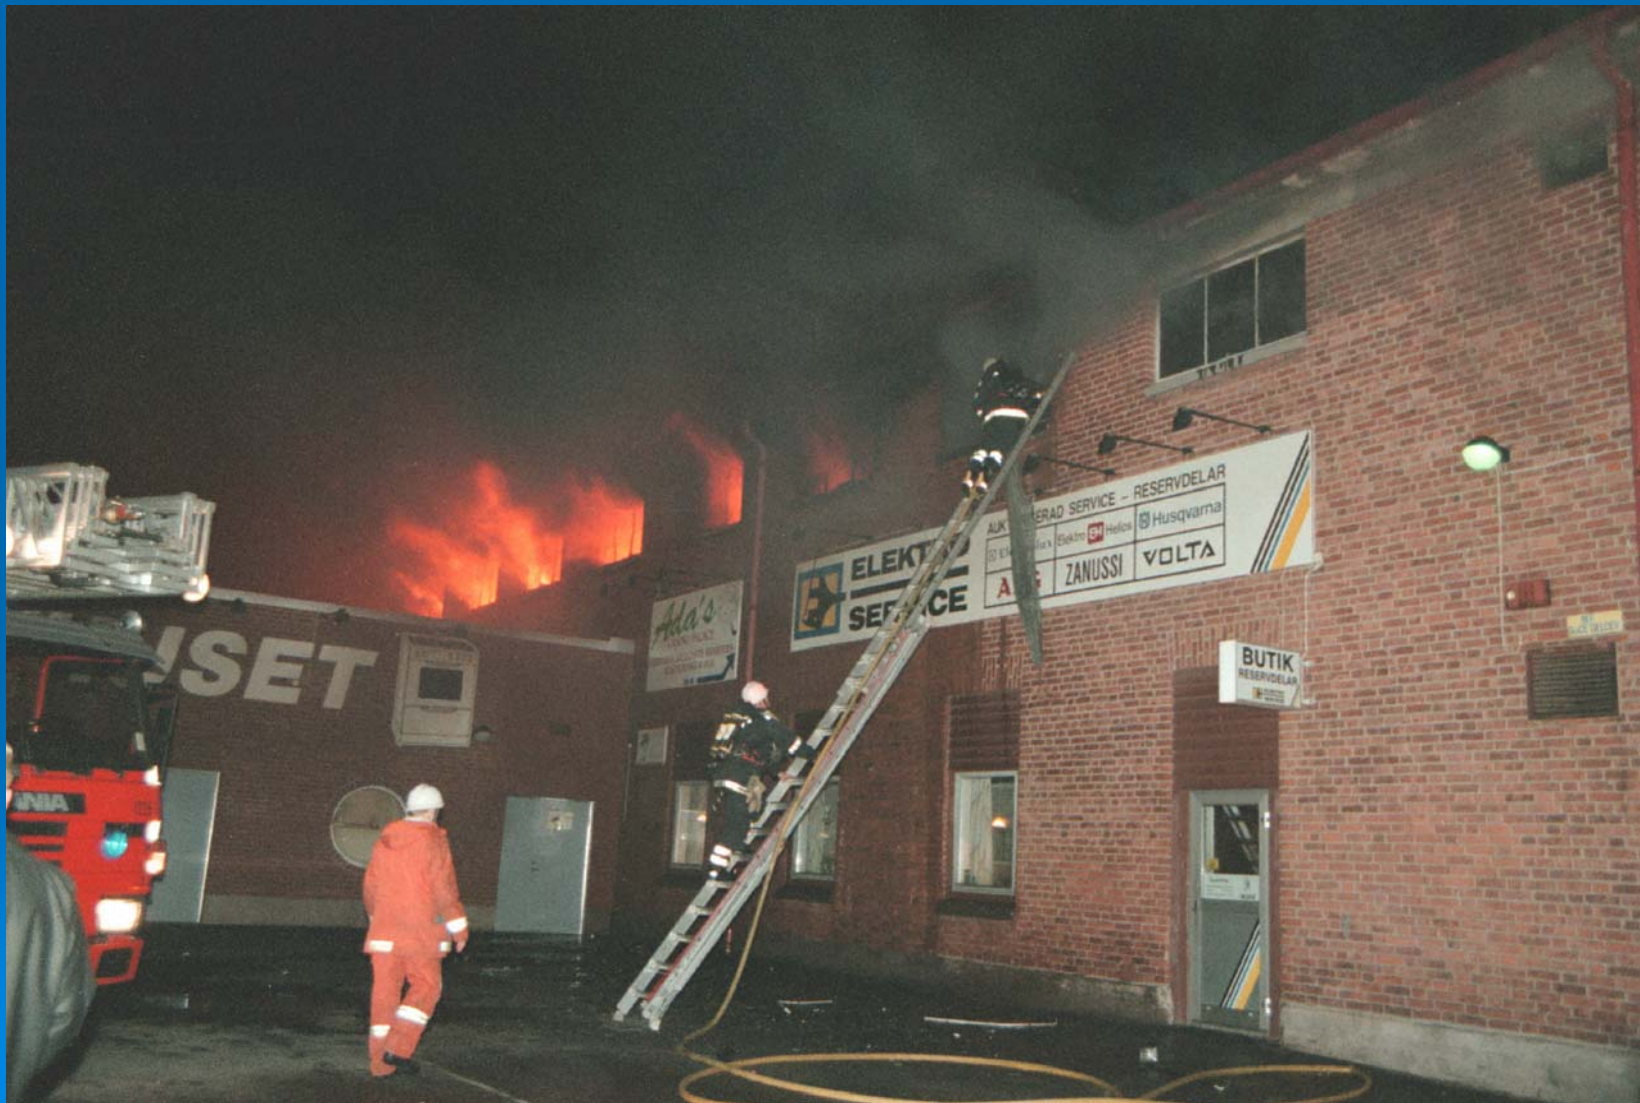
Gothenburg – fully developed fire.

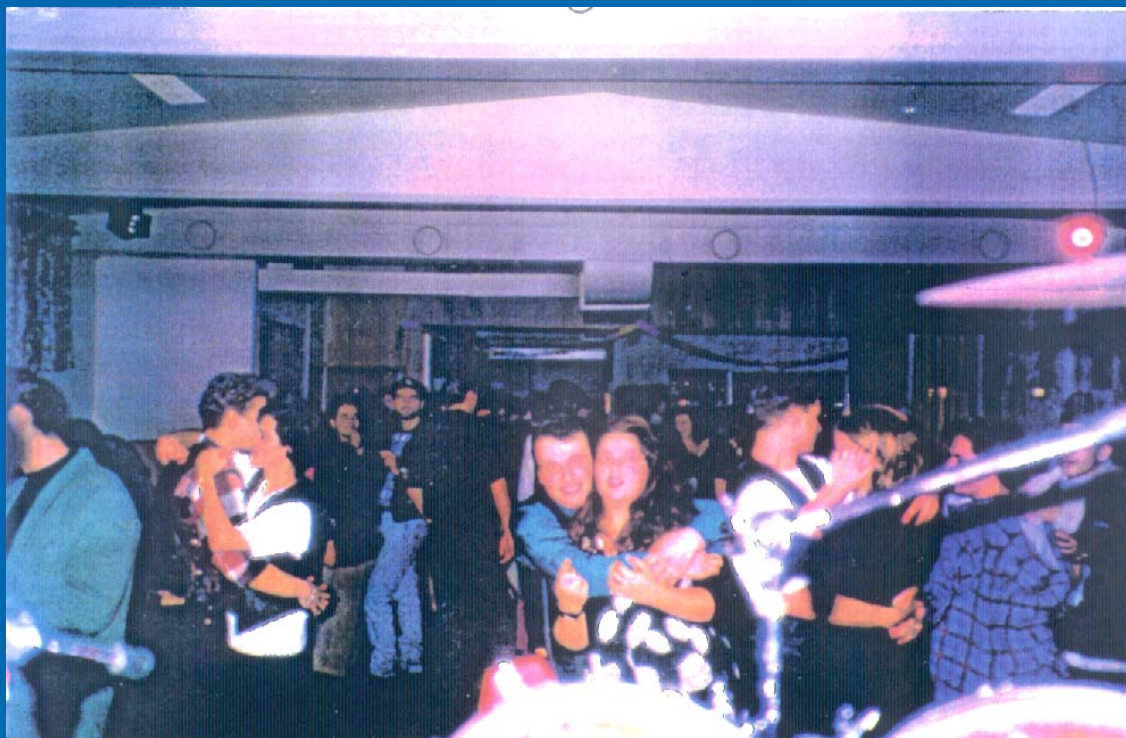
Gothenburg dance hall in use

- Typical use of hall before the fire. Note the low ceiling and down-stand beams
- On the night of the fire the hall had been rented for a Halloween party by high school students. It was so crowded that it was impossible to dance.

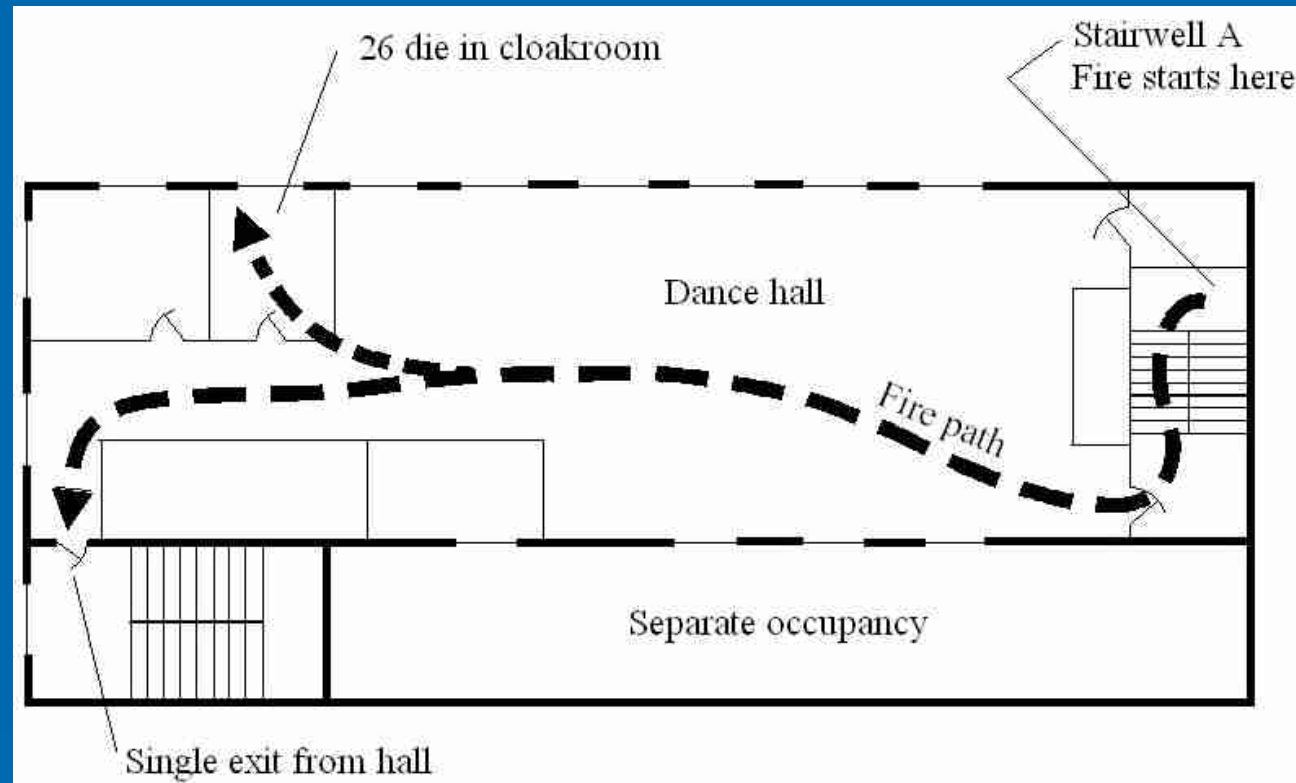
Dance hall - fire route

- There was an exit served by a dogleg staircase at each end of the hall, hence there were two well-positioned escape routes provided as required.
- The stairwell (Stairwell A) in which the fire occurred was made of brick and concrete.
-
- The doorways onto the stairs were 800 mm wide and opened in the direction of travel; the stairs were 1.5 m wide.

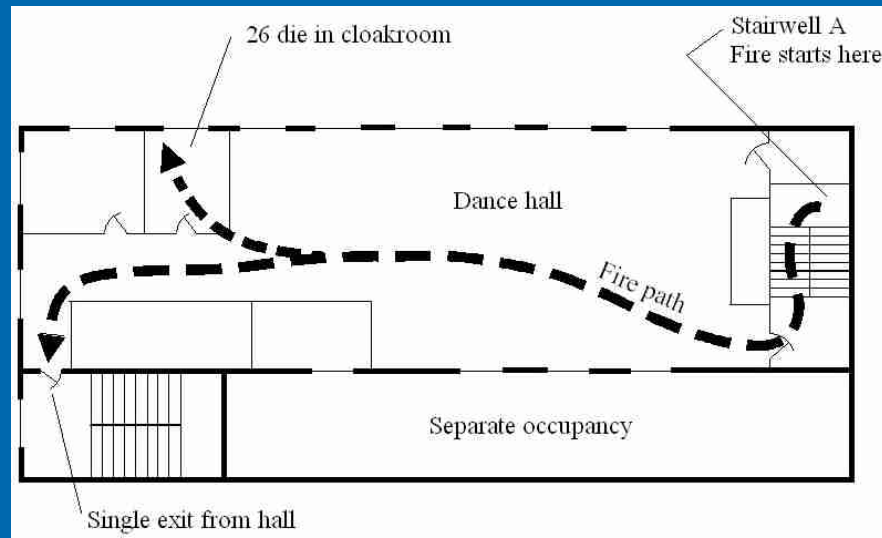
Gothenburg – the fire

- The fire started on the lower landing of Stairwell 'A' which had been used temporarily to store about 40 stacked chairs
- The fire was discovered when the disc jockey opened the door to the staircase.

- The DJ phoned the fire brigade on his mobile phone and, realising he would not be able to get to the other staircase to escape, broke and jumped through a window onto the adjoining roof.
- When the door to the discotheque hall was opened toxic smoke, and soon after flames, spread into the hall, and the linoleum floor covering became ignited due to radiation from the hot ceiling gas layer.
- The students tried to get out through the one remaining exit while 26 youngsters took refuge in a cloakroom near the exit, but the fire broke through the glazed area above the partition and those occupants died by smoke inhalation.

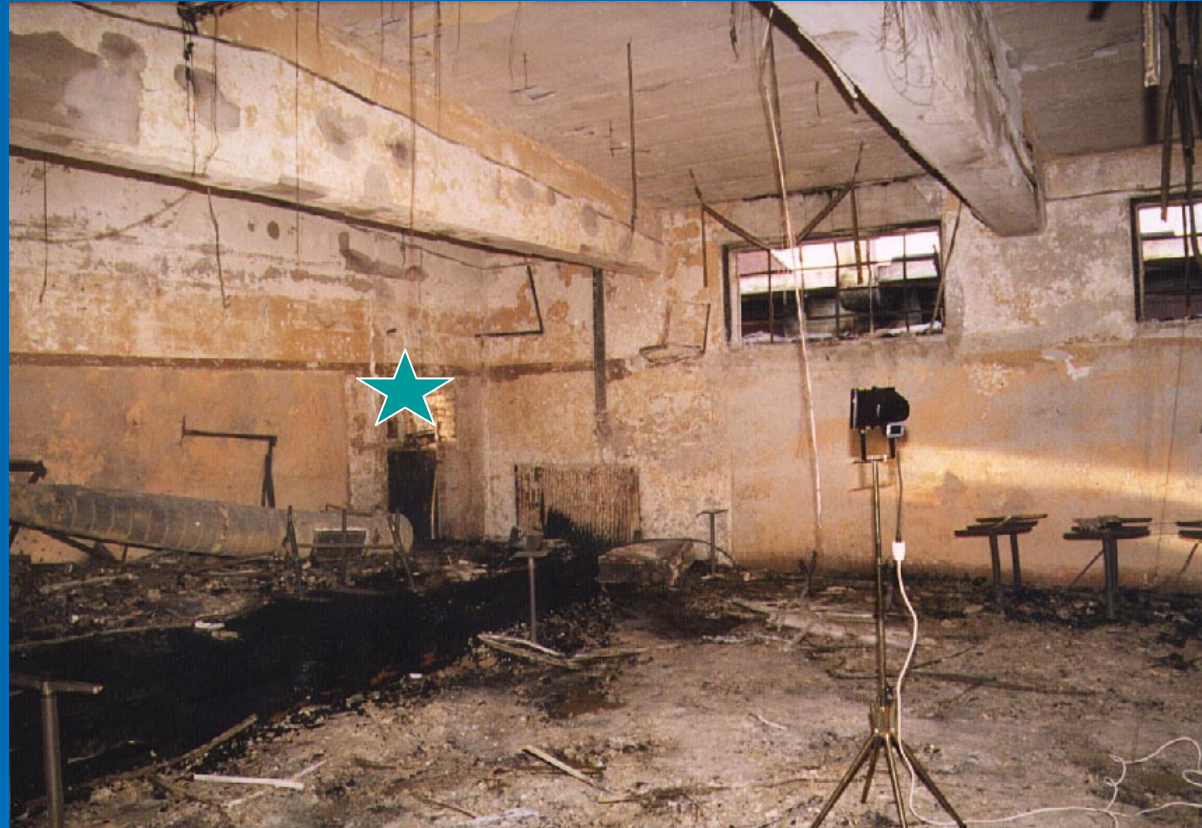
The hall after the fire

- Below the green star is the door from the staircase. Fire in staircase burst into the hall when this door was opened by DJ
- Fire has consumed all combustible material in the room including floor coverings. Remains of stage is at left hand side.

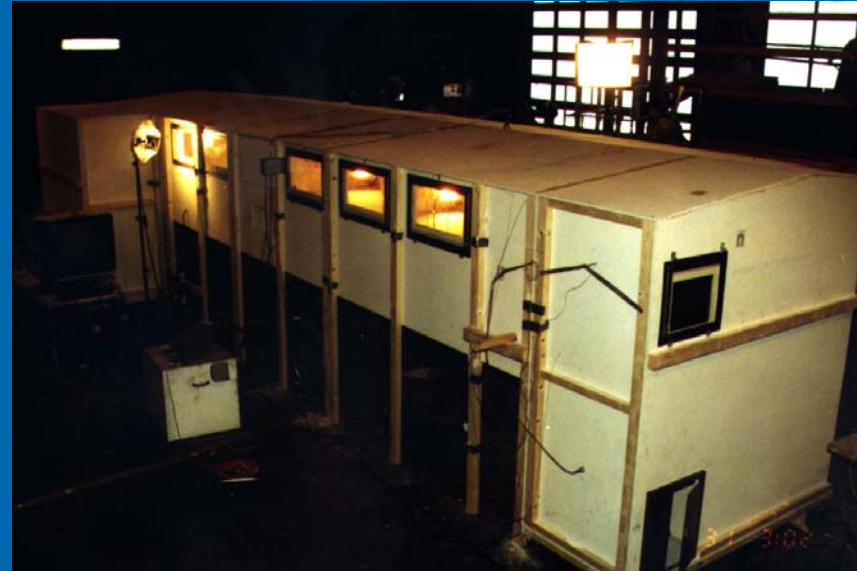
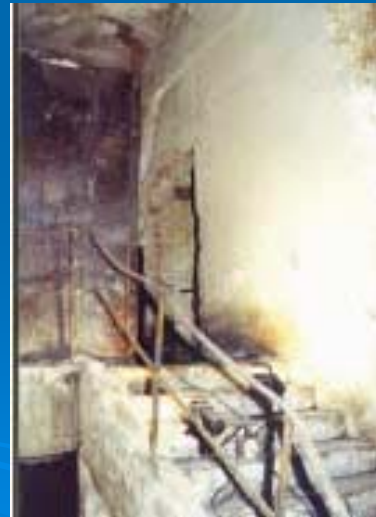
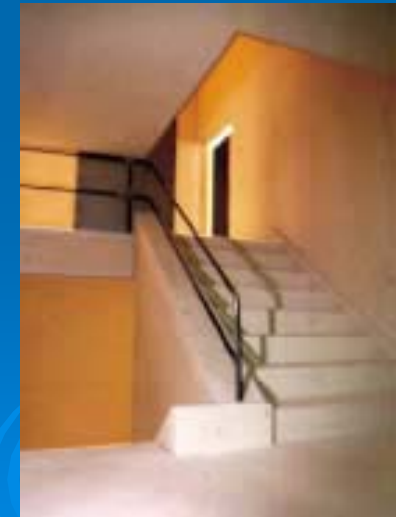
- SP constructed a quarter-scale model of the discotheque and made 13 fire tests therein which involved the use of timber cribs as the fire load
- In Sweden, fire tests in scaled models had not previously been used. The real staircase and model staircase in which the incipient fire occurred are shown here.
- The aim was to get the same maximum rate of heat release in the model and full scale condition. 40 chairs were estimated to produce 4000 kW in 20 minutes, corresponding to a maximum rate of heat release of 125 kW in the model at 10 minutes.

- The ignition and fire growth tests showed that, while it may not be possible to ignite an item with a match, using a larger fire source together with a stacked configuration of chairs led to a severe fire. This should be a lesson to those who sell their product or approve the products of others by reference to misleading ad hoc tests using an unrepresentative small heat source.

- The chairs only burnt when they were stacked on top of each other – a finding reflected in other studies

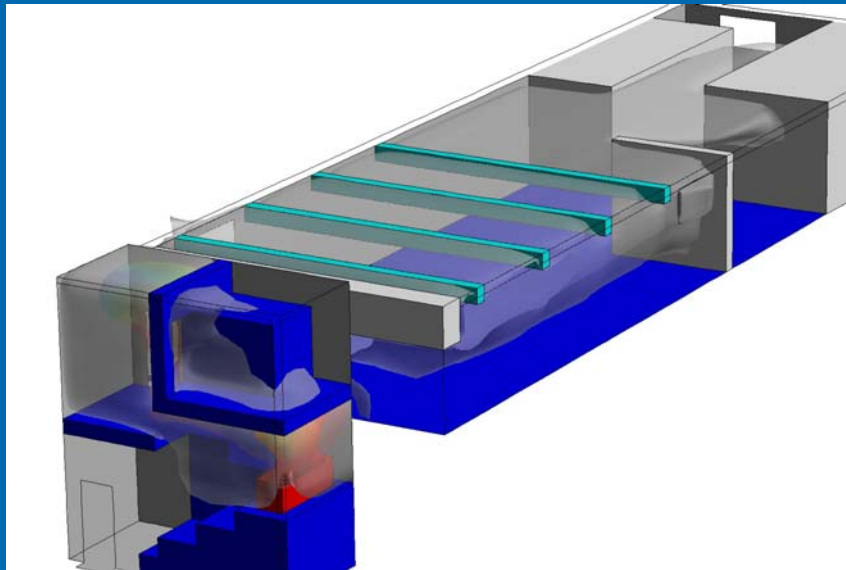
SP fire modelling

- The fire has been numerically modelled by SP using computational fluid dynamics (CFD). The CFD simulations were made using the SOFIE (Simulation Of Fires In Enclosures) software.
- This 3-dimensional graphic shows a smoke and heat condition at a particular time (10 minutes after ignition), one of many conditions simulated, after the door to the hall was opened.

- Modelling the fire showed without doubt how the fire had started and why it spread so rapidly. This placed great responsibility on the modellers as their findings contributed to the verdict of murder given to the four boys who started the fire.

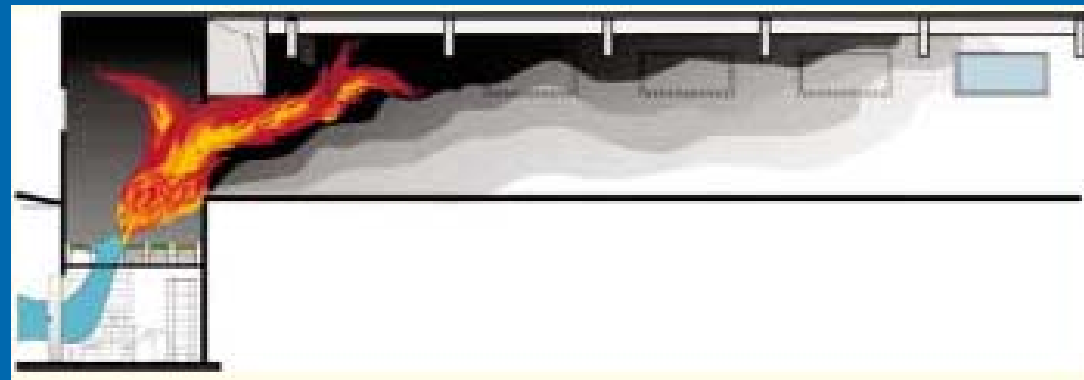
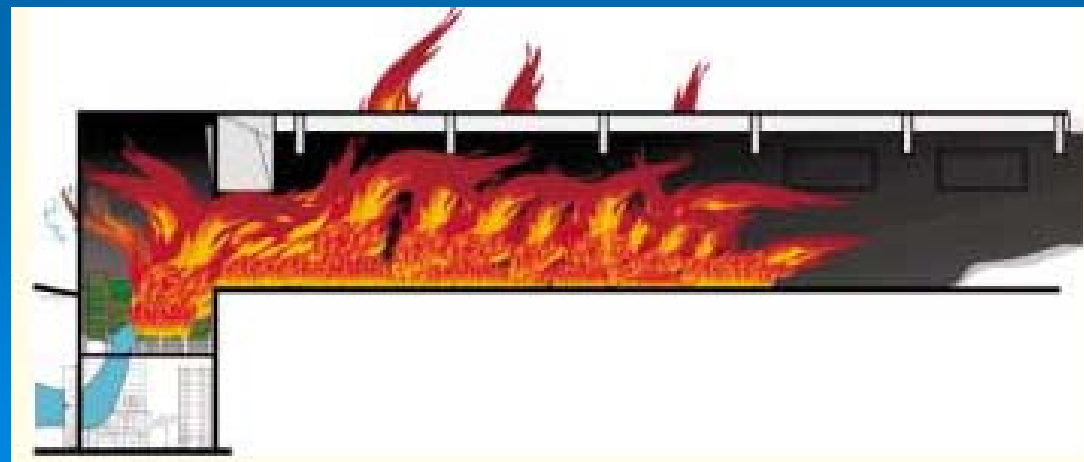
Gothenburg fire simulation.

upper diagram - 2 minutes after ignition

lower diagram - at flashover

Note ignition of plastic floor tiles

- The low ceiling in the hall meant there was no beneficial smoke reservoir in the hall
- The unusual contribution to fire spread by the floor covering could be explained by the low thermal inertia (kPC) of the fibreboard and linoleum which formed the hall floor covering.

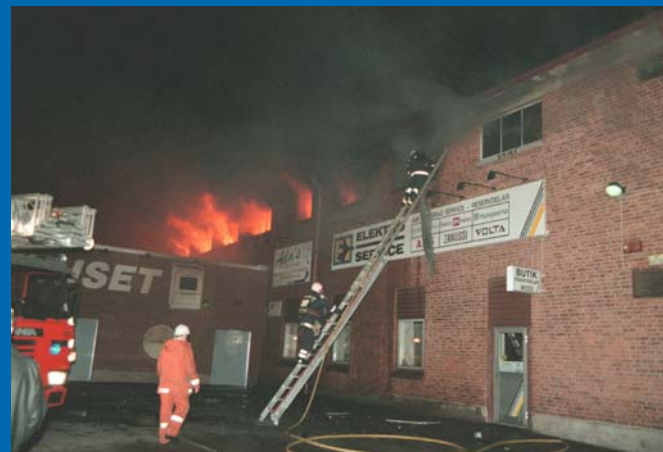
Gothenburg – predicted time line

- Having conducted the programme of fire tests and modelling SP were able to predict the course of events as follows:
- 23.30 approx. Fire in stairwell started maliciously
- 23.42 Door between stairwell and hall opened and left open
- 23.44 Smoke has spread to other end of the hall, students try to escape from second exit
- 23.57 Fire is fully developed in hall and flames are jetting out of windows, radiation and flames are sufficient to ignite the eaves of the Backa theatre 5 m away
- 24.30 Door at foot of stairwell closed
- 02.00 approx. Fire out
