# Stardust disco, Dublin, February 1981

# Stardust – building plan

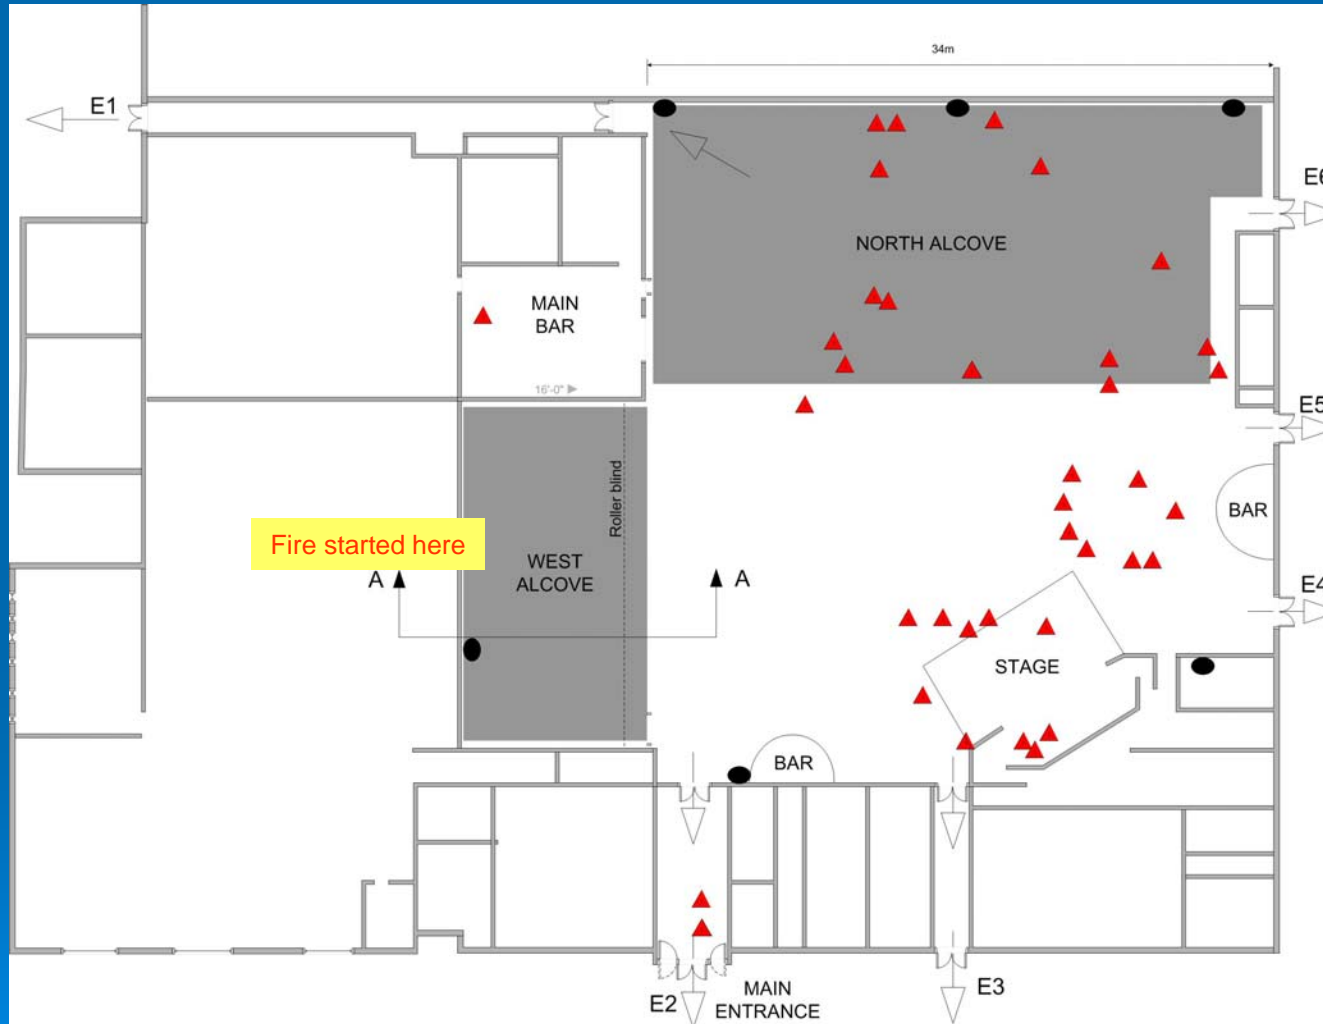
Red triangles show positions of the dead bodies.

6 black-filled dots show positions of fire extinguishers

Final exits are indicated by E1 to E6

Fire started at back of West Alcove.

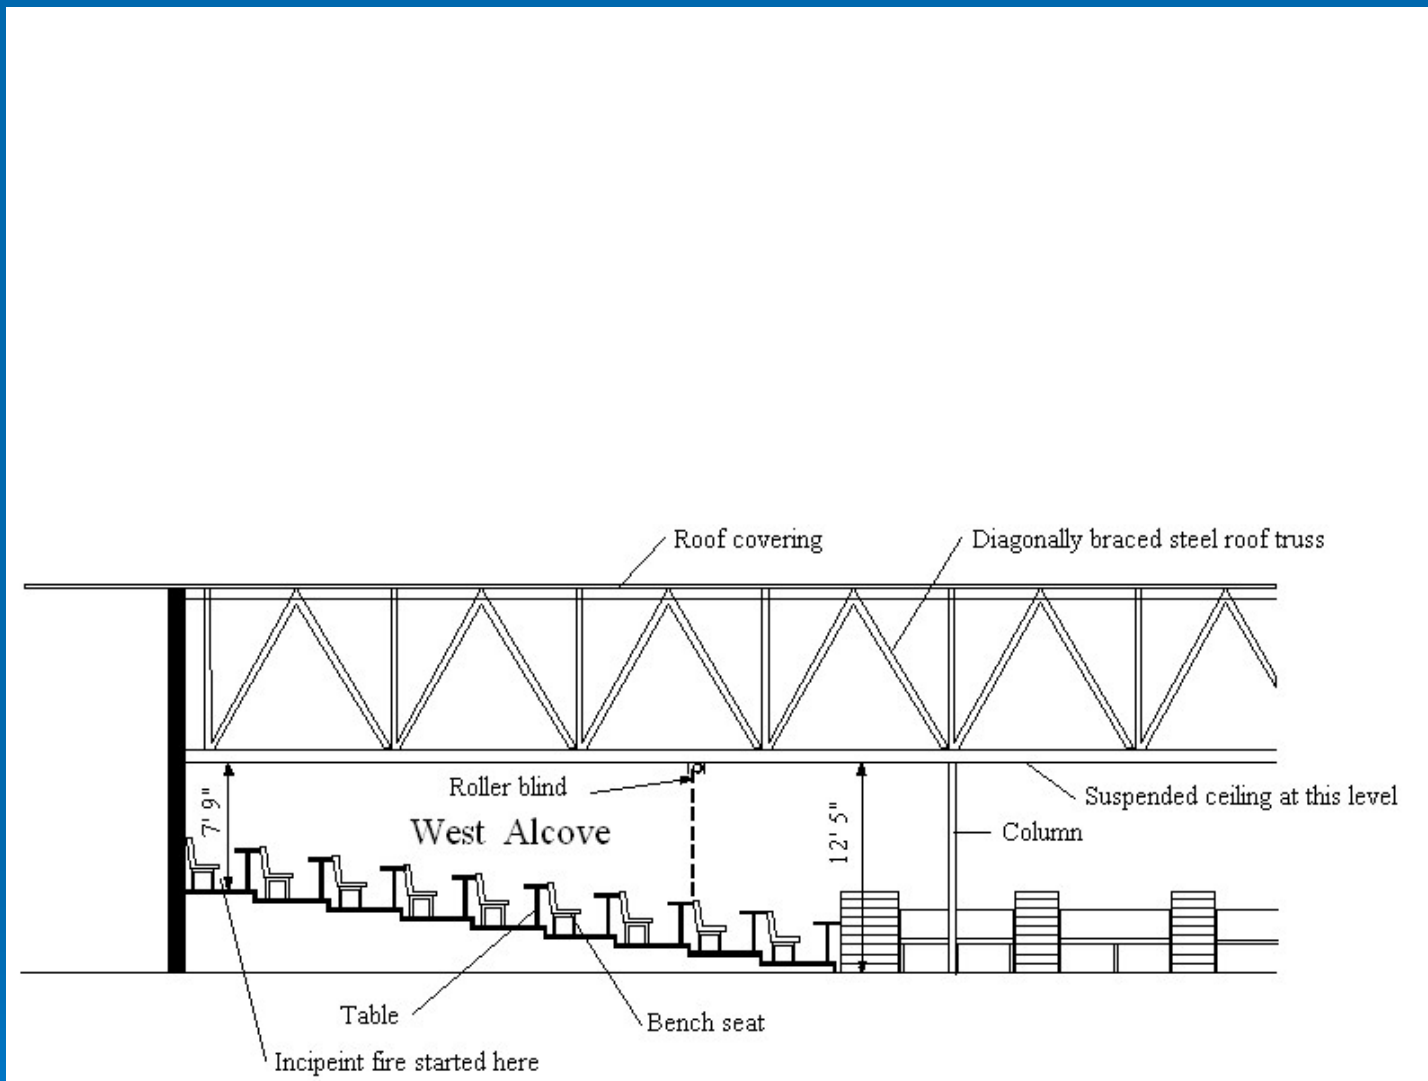
- Section through West Alcove showing ramped seating and low ceiling. Shows where fire started.

- The roof was of steel trusses with asbestos cement sheeting on top with a suspended ceiling of mineral fibre tiles below. Floor to ceiling height was 3.8 m except at the back of the alcoves where it was only 2.3 m due to the sloping stepped floor.

- There were two large alcoves; the West Alcove, where the fire started, and the larger North Alcove.
- The West Alcove had a roller blind of plastic which could be used to close off the alcove. This blind was in the down position at the time of the fire. The alcoves had bench type tables and fixed tiered seating upholstered on the seat and back with polyurethane foam covered with PVC fabric.

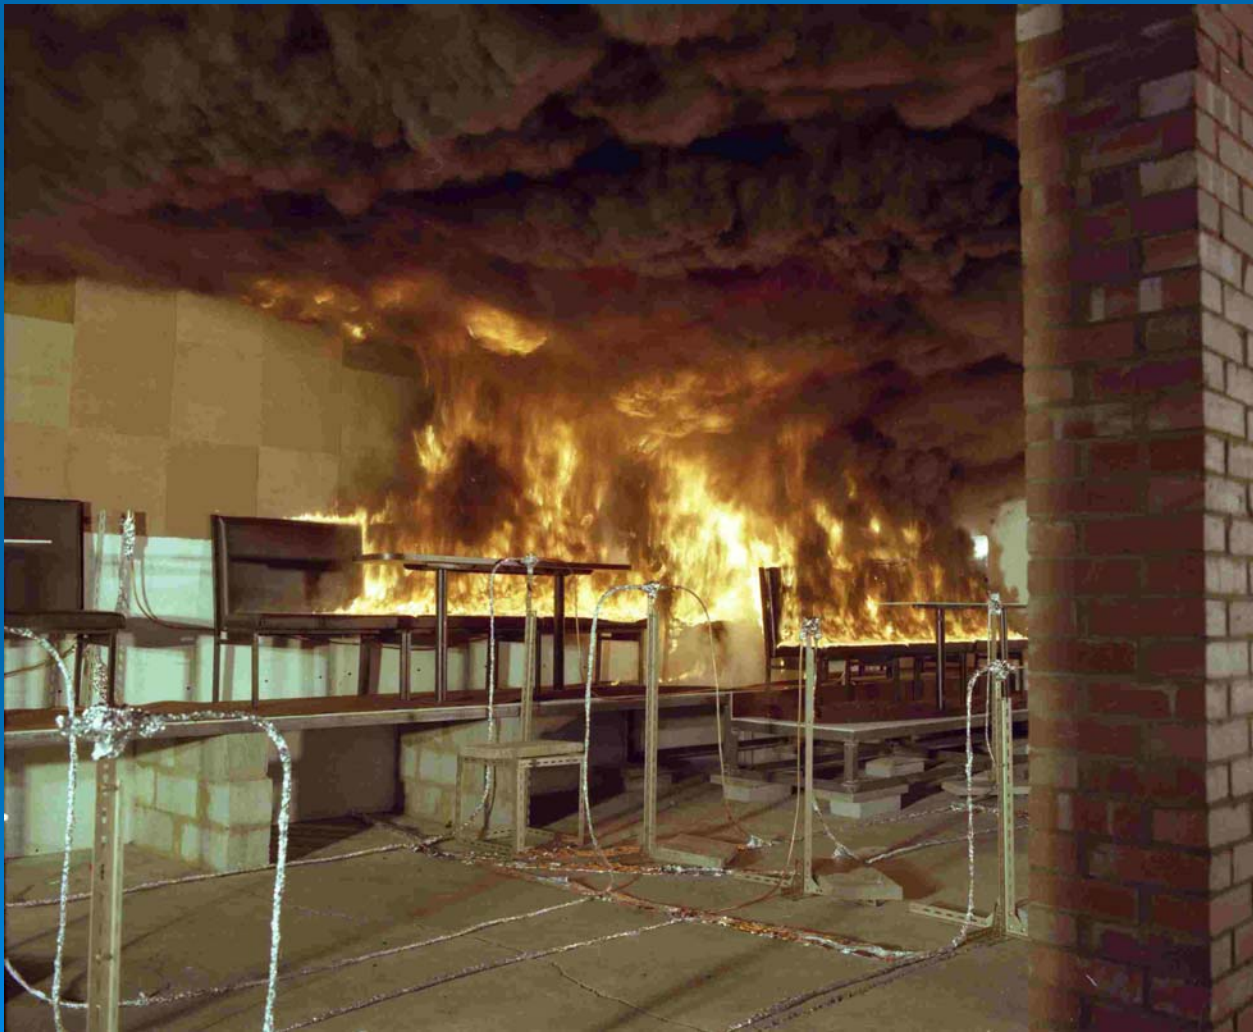
# Stardust – BRE full scale simulation

Fire on rear bench has spread laterally and involved the combustible wall tiles.

Note black smoke flowing under ceiling.

Water-cooled radiometers are on stands

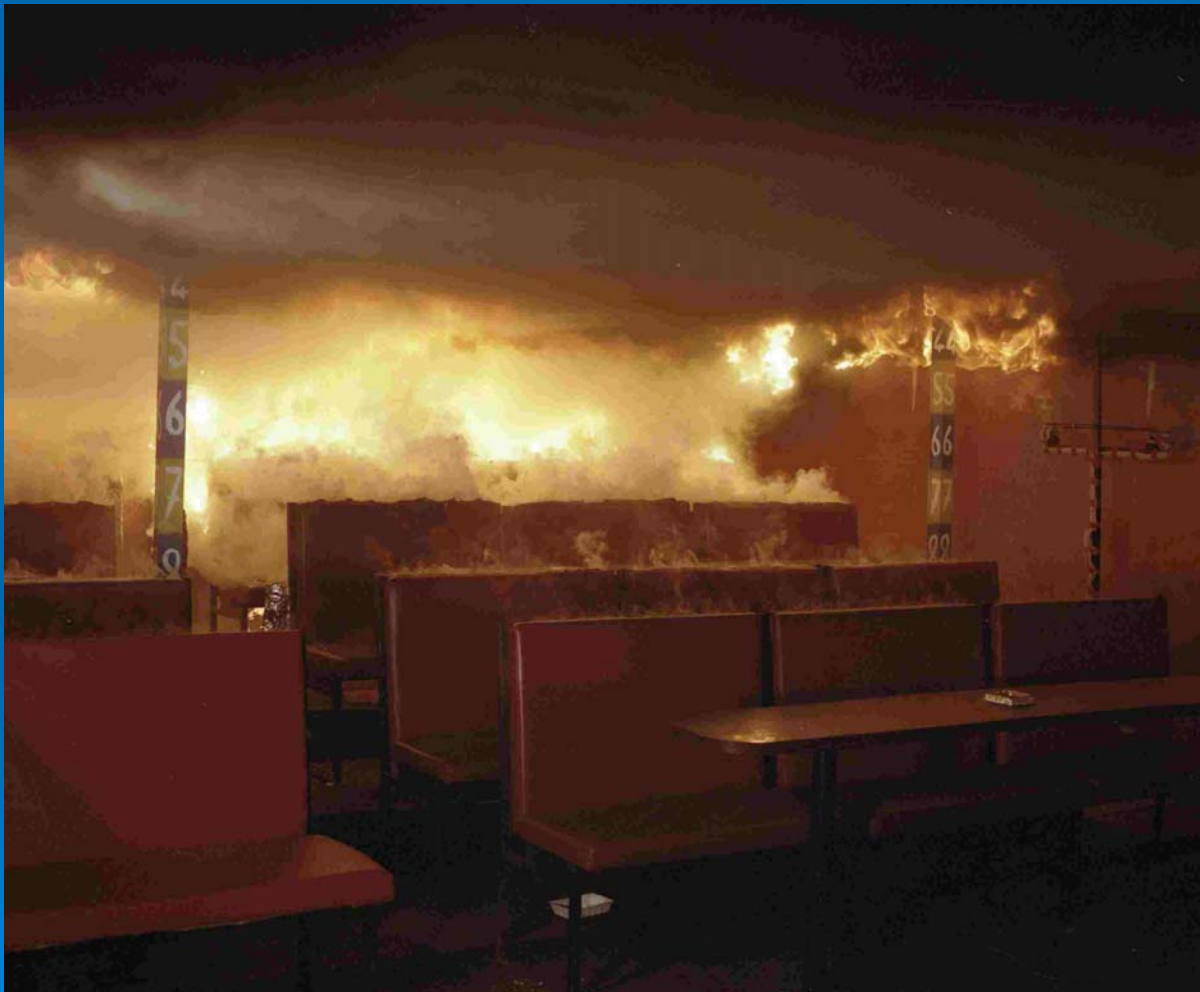
# Stardust – BRE final simulation

The point of flashover.

Note smoking of tops of bench seats. These are near the point of autoignition due to radiation from hot gas layer.
