# Taunton sleeping-car train, UK, 1978

# Taunton - summary

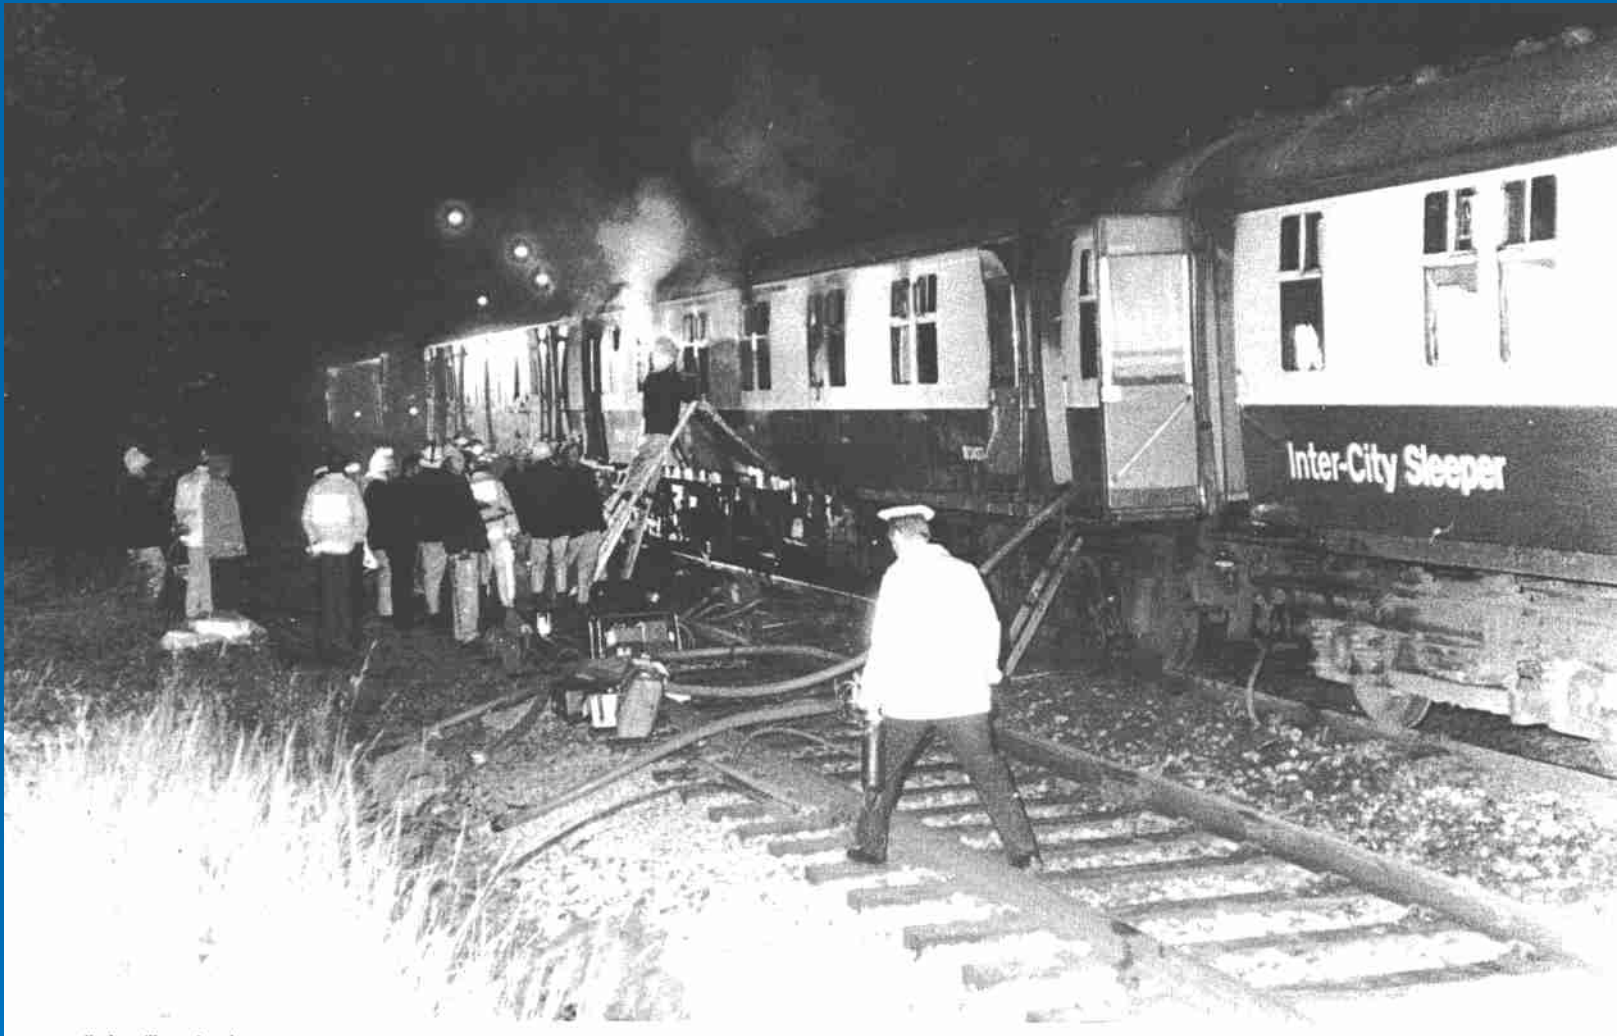
- Taunton sleeper train. Night time, the train has stopped, rescue is in progress.

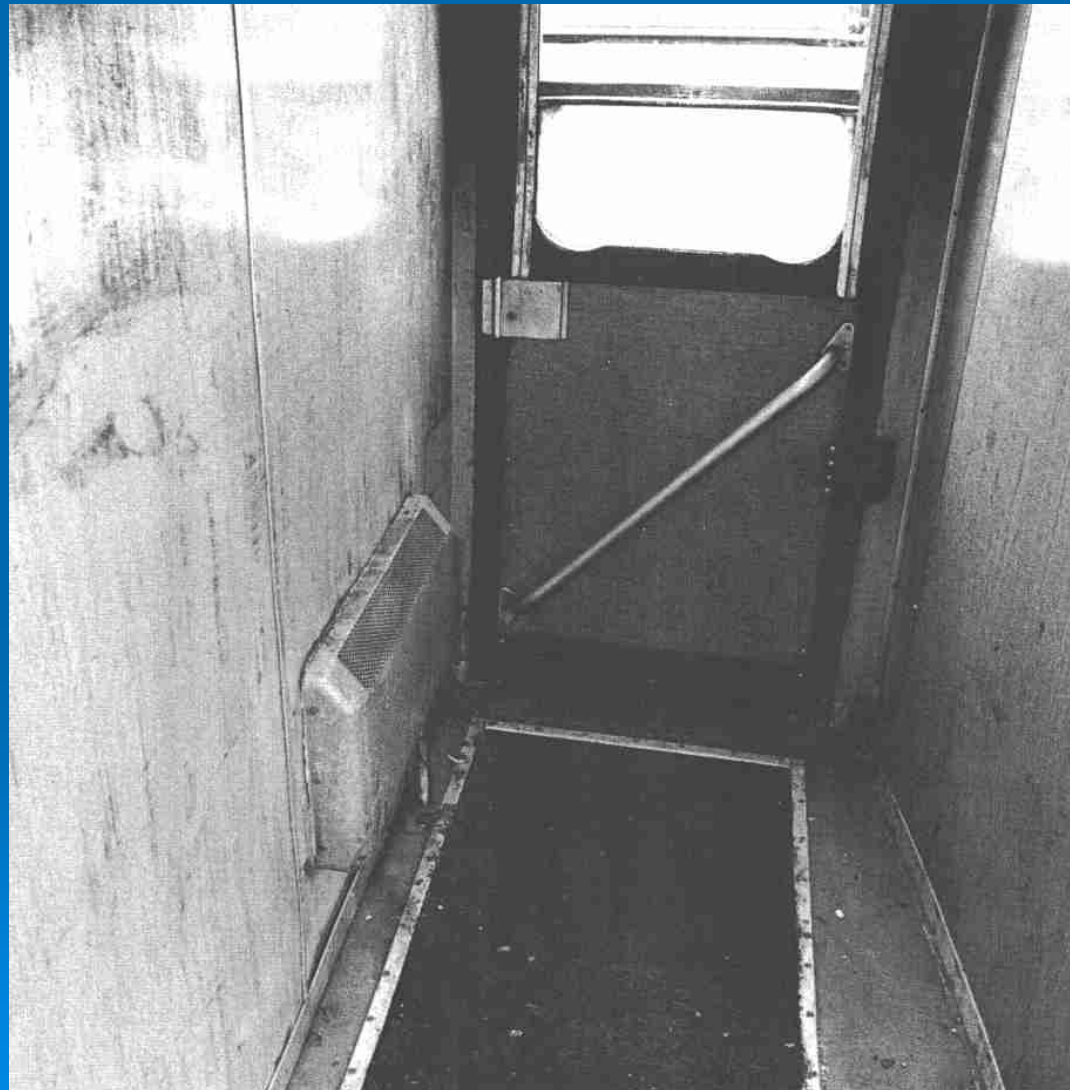
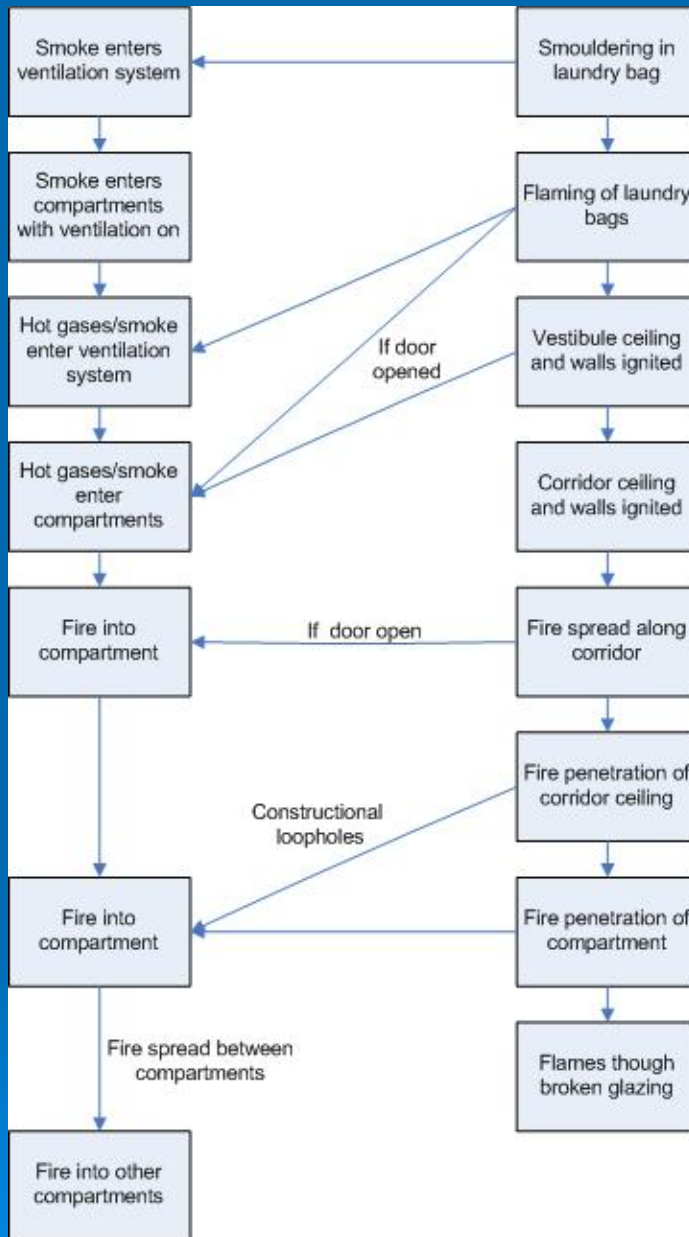
# Taunton – vestibule heater at end of corridor.

Bags of linen were placed against the electrical heater seen here on partition. Door is carriage door.

- Examination of the fire debris strongly suggested that the bags of linen next to the vestibule heater, had smouldered, and BRE were commissioned to undertake ignitability tests.
- It was concluded that fire started in the front vestibule area involving the bags of linen possibly ignited, via a smouldering process, from a heater. Fire then spread by ignition of the wall and ceiling linings in the vestibule area and spread to ceilings in the corridor, leading to subsequent involvement of some compartments.
- Fire could spread in at least two ways depending if and when compartment doors were opened , as indicated in the flow diagram. Most fatalities were found in the compartments The pathologist observed that only 1% carbon monoxide could be lethal and one could die quietly while asleep

- Smoke detection might be used to give early warning of fire. This was explored but found not to be practical due to false alarms caused by dust, temperature variations, air movements and vibrations
- Mattresses incorporating conventional polyurethane foam were highly flammable and should be removed.

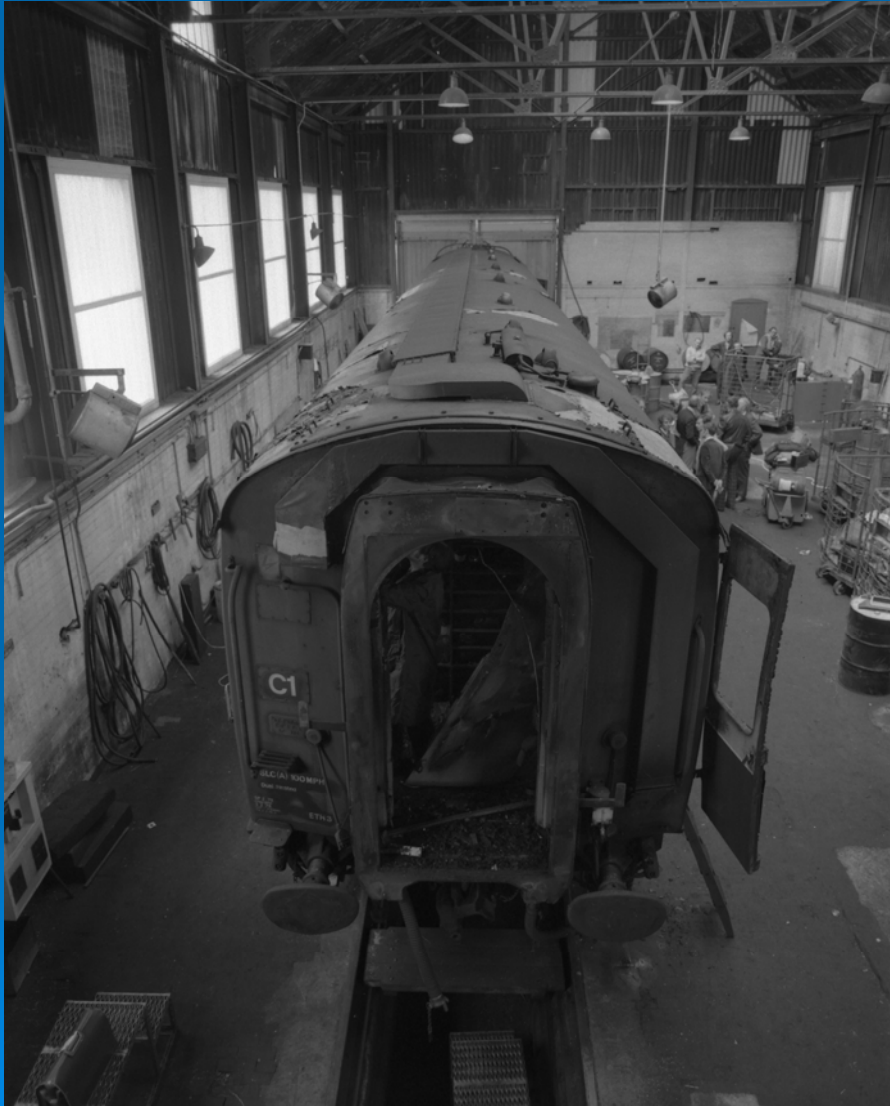
# Taunton – damaged car

- Fire-damaged carriage in railway workshop being examined forensically.
- Note paint burnt away on roof above vestibule clearly indicating severe fire location
