Flixborough petrochemical plant, 1974

Flixborough – the site

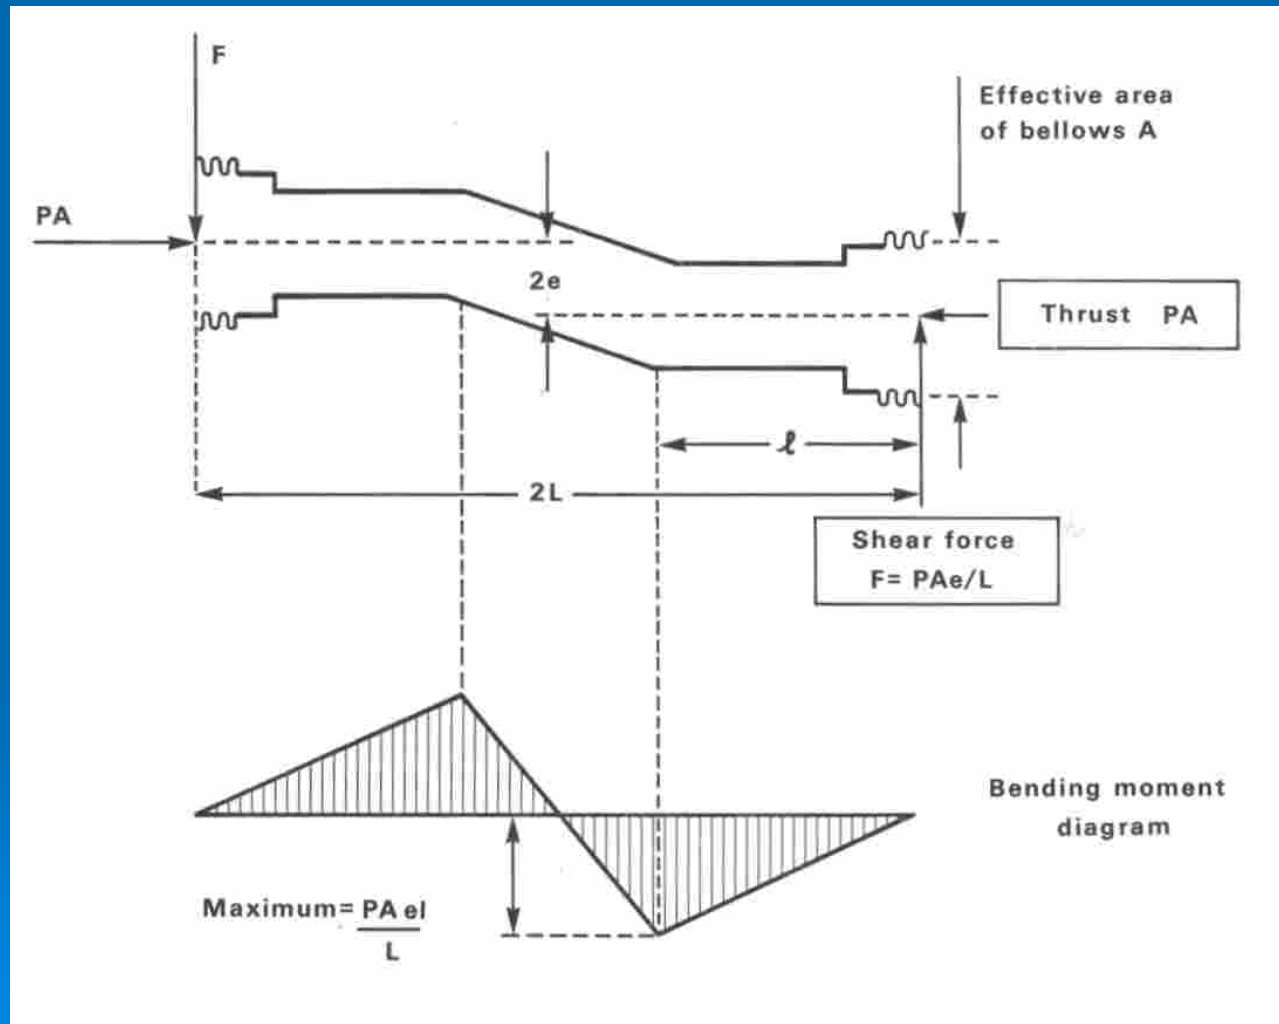
Flixborough – forces on bypass pipe

- The explosion occurred at 16.53 on Saturday 1st June 1974. The sequence of events is unclear.
- Two hypotheses were considered in the Inquiry report: failure of an 8 inch pipe and, separately, failure of the 20 inch by-pass as the pressure was increased (as the plant was being brought fully on line after the fitting of the bypass).
- The preferred hypothesis was failure of the 20 inch by-pass pipe which occurred by downward deflection of the supporting scaffolding pole followed by 'squirming' of the bellows and rupture of the lower mitre weld in the dogleg pipe.

- This precipitated failure of the mitre weld and, under the action of the axial compressive load, caused the bypass to jack-knife, so allowing escape of cyclohexane.
- It seems likely that if the assembly had been tested to 11 kg/cm² the by-pass pipe and bellows assembly would have failed and the disaster would have been averted.
- The Inquiry report did not speculate on how the vapour cloud was formed in the Flixborough plant but recommended that further research was necessary on the required conditions for unconfined massive vapour cloud explosions.

- The disaster was caused by poor design and inadequate structural support (with flexible scaffolding poles) of a temporary 20 inch diameter bypass pipe
- Structural calculations for the bypass were not carried out - such calculations might have anticipated the failure mechanism
- There was inadequate recognition by management that a calculation and proper pressure test was necessary for the bypass - there was no Works Engineer employed at the works at the time. There was too much reliance on chemical engineers in the management team.
- After the explosion the phenomenon of squirming was demonstrated with large scale tests on bellows subjected to shear force
