Joelma

Joelma – the building

Joelma – fire timeline

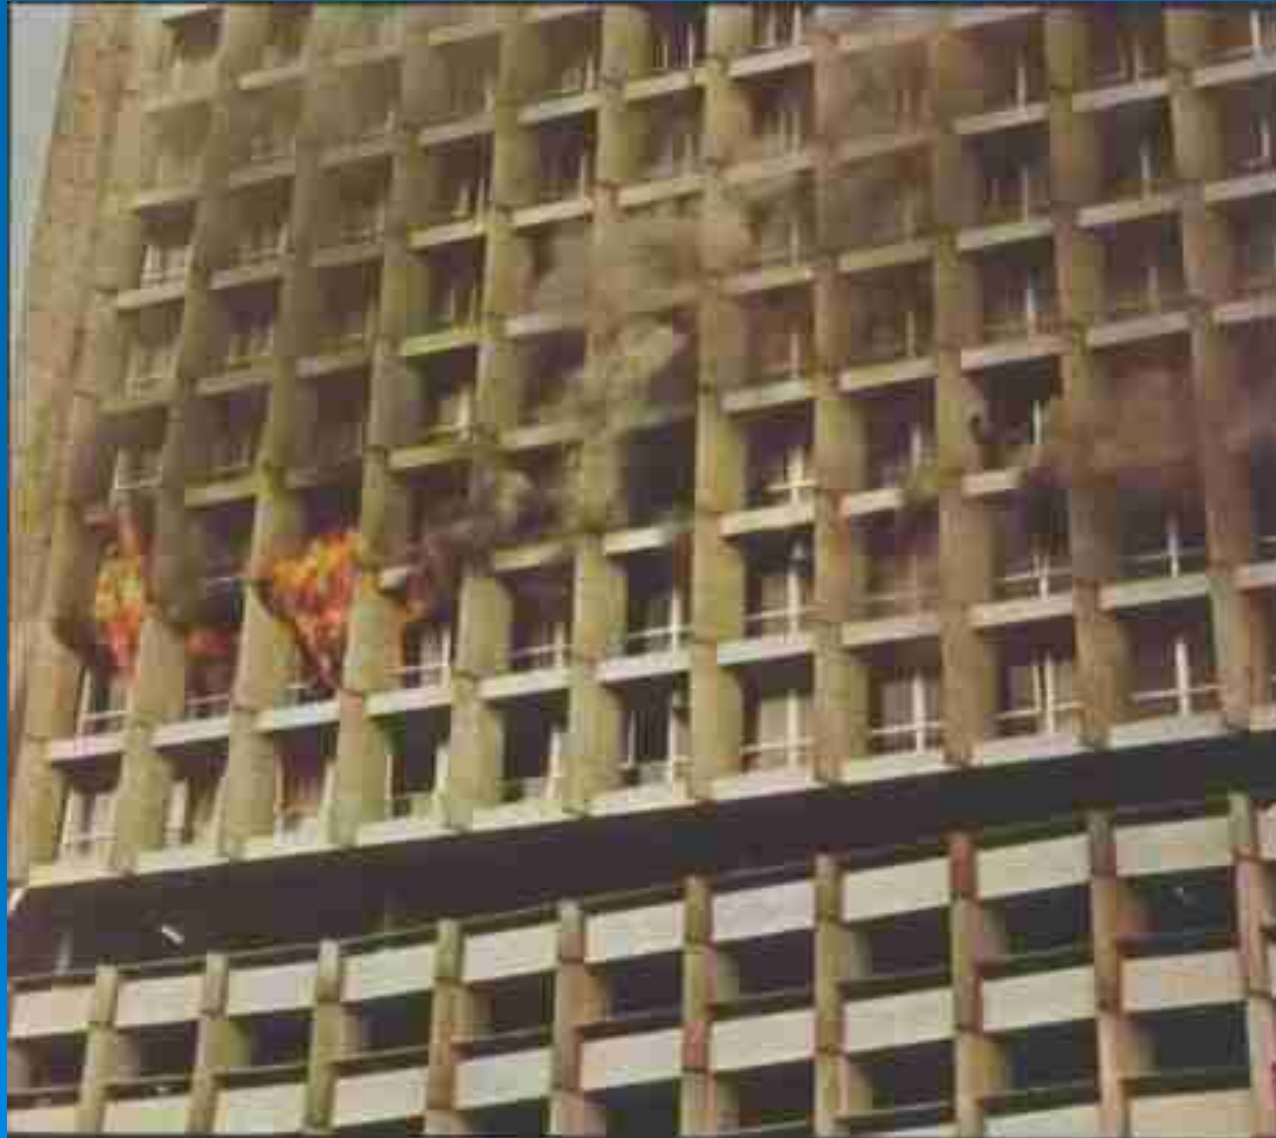
Joelma fire

- Fire started due to an electrical fault caused by lack of a circuit breaker
- Whereas the concrete structure was demonstrably fire resisting, the interior finishes (partitions and ceilings) were entirely of combustible materials and this encouraged rapid fire spread
- Only one stairway was provided and it was not enclosed – smoke and fire could and did spread internally from storey to storey
- There was no fire separation between the two office wings
- There were no local evacuation alarms, no exit signs, and no emergency procedures for occupants
- The lifts were used intelligently and they stopped only at wanted floors. Luckily the power supply to the lifts was not affected early on and some 300 people were evacuated by lift
- Downdraft from helicopter rotors was said by some survivors to be a help to survival for those taking refuge on the roof.
