Joelma

Joelma – the building

Joelma – fire timeline

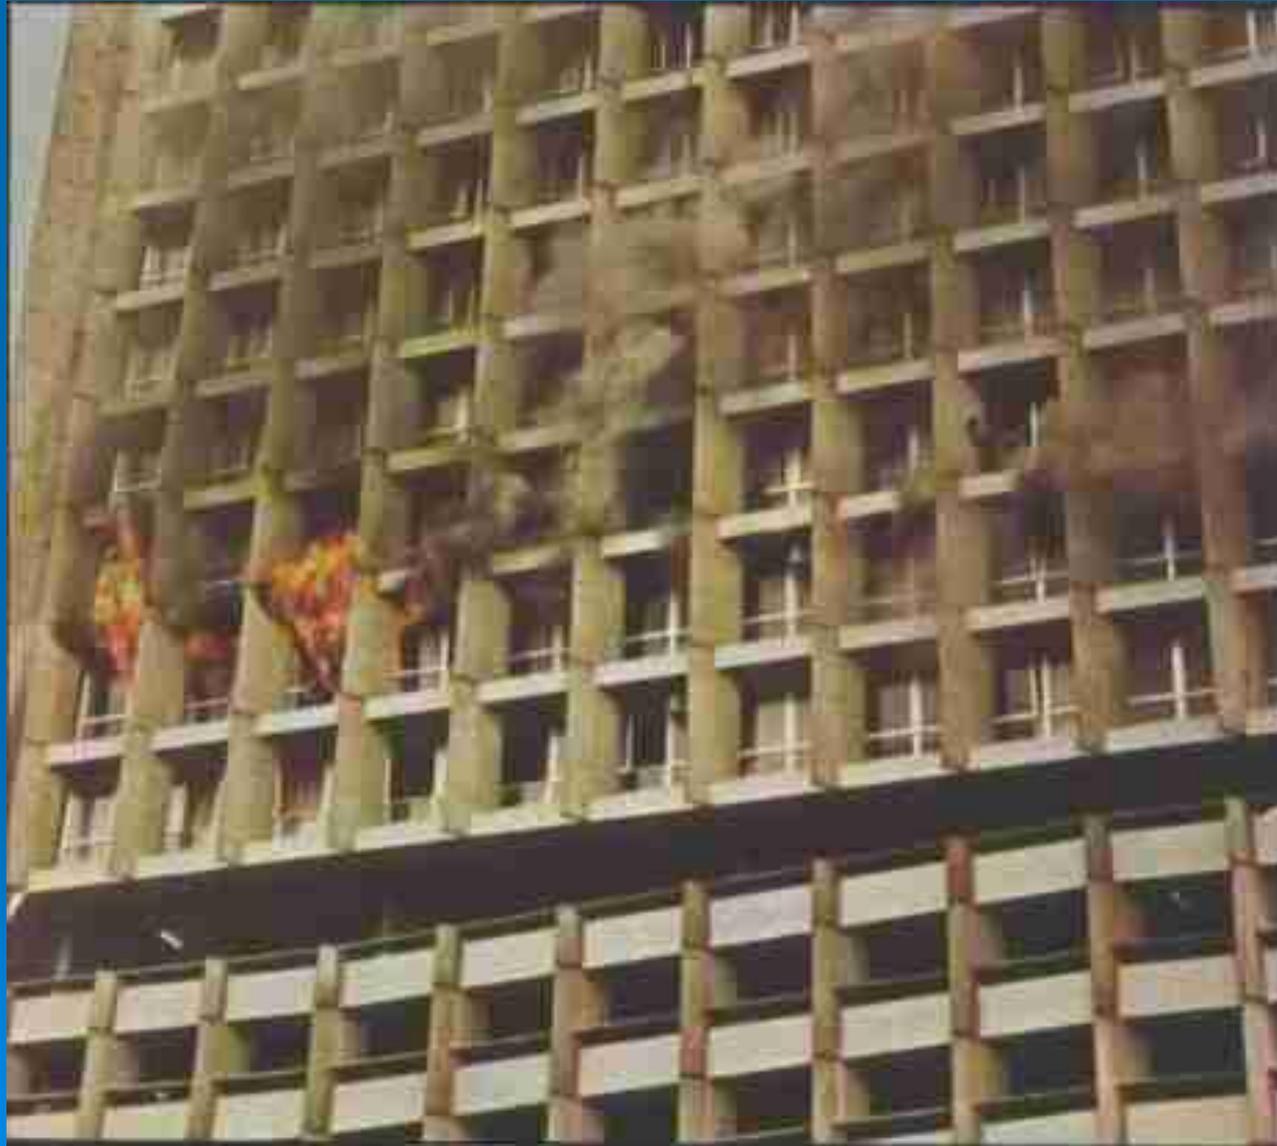
Joelma fire

- 08.50. A crackling sound heard coming from a window-mounted air-conditioning unit on the 12th floor, and Supervisor shuts off local electrical supply. Curtains caught fire and fire started to spread. Fire said to be too smoky to fight with a fire extinguisher. Meanwhile another employee went to the first floor to prevent more workers from entering the building. The 4 lifts were then used to evacuate several lift-loads (estimated at 300 people) and lifts are eventually grounded.

- 09.03 Occupant of building across the street sees the fire and phones the fire brigade
- 09.10 Fire brigade arrives and are faced by fire rapidly spreading up the two window walls. Occupants get onto the 0.9 m spandrel (portion of floor slab which projects beyond window) at several storeys seeking air and rescue from fire brigade. Fire involves storeys 12 to 20. It is impossible to enter the building. Many occupants go to the roof expecting to be lifted off by helicopter, while others jump from windows causing a hazard for the fire fighters

- Fire started due to an electrical fault caused by lack of a circuit breaker
- Whereas the concrete structure was demonstrably fire resisting, the interior finishes (partitions and ceilings) were entirely of combustible materials and this encouraged rapid fire spread
- Only one stairway was provided and it was not enclosed – smoke and fire could and did spread internally from storey to storey
- There was no fire separation between the two office wings
- There were no local evacuation alarms, no exit signs, and no emergency procedures for occupants
- The lifts were used intelligently and they stopped only at wanted floors. Luckily the power supply to the lifts was not affected early on and some 300 people were evacuated by lift
- Downdraft from helicopter rotors was said by some survivors to be a help to survival for those taking refuge on the roof.
