# *Star Princess* cruise ship, 2006

## *Star Princess – the fire*

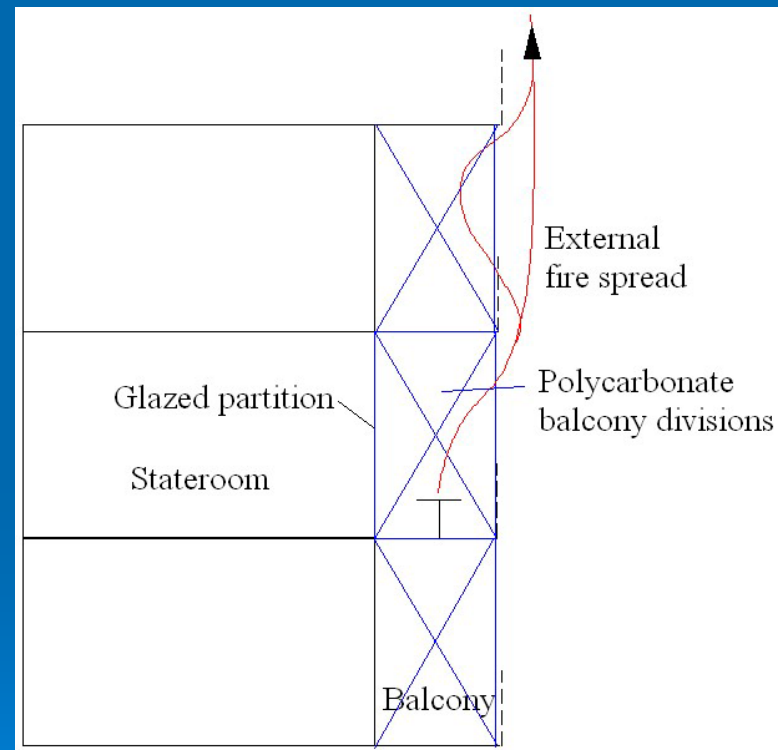
- The seat of the fire was on an external stateroom balcony sited on deck 10 on the vessel's port side.
- The fire spread rapidly along adjacent balconies, and within 10 minutes had spread up to decks 11 & 12 and onto stateroom balconies in two adjacent fire zones.
- The fire also spread internally as the heat of the fire shattered the glass in stateroom balcony doors, but was contained by the fixed fire suppression system fitted in each of the staterooms.
- As the fire progressed, large amounts of dense black smoke were generated from the combustible materials on the balconies, and the polycarbonate balcony partitions.

right – vertical section through 3 decks of state rooms and balconies

- Plastic sheet balcony dividers should be replaced with dividers of non-combustible material.
- Increased vigilance is necessary and review of crew's on board fire fighting response needs to be reviewed.
- Passengers and crew should be advised not to leave towels and personal belongings on balconies when they are not in their rooms.
- Passengers should be reminded a) not to throw any items over a ship's side from balconies or other external areas and b) not to use unauthorized heating elements such as electrical heating coils used in cups or mugs and open flames such as candles.
