Andraus high-rise, Sao Paulo, Brazil, February 1972

Andraus – the building details

Andraus – the fire

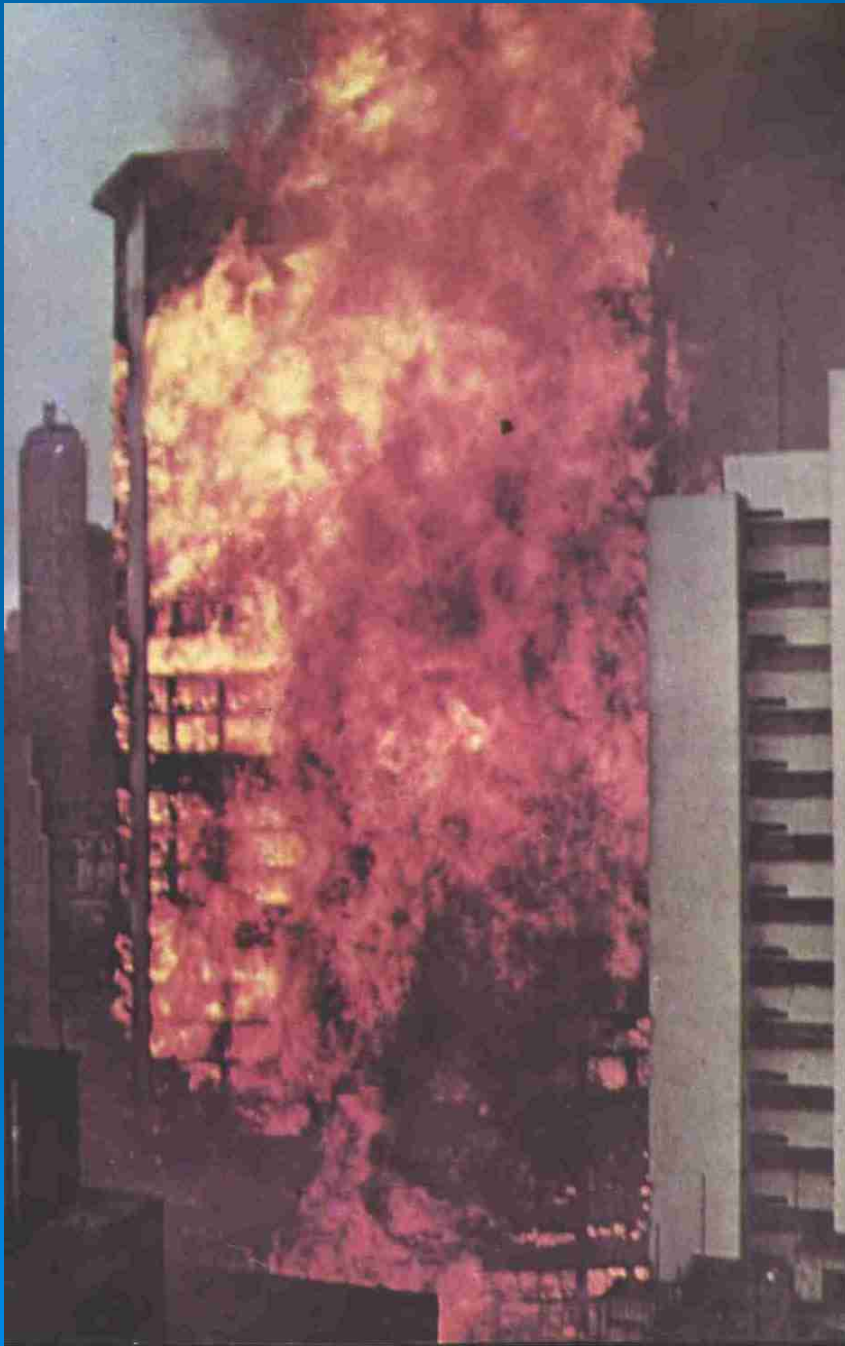
- Multi-storey fire in 31 storey Andraus building. Fire has spread throughout presenting a major external radiation hazard.

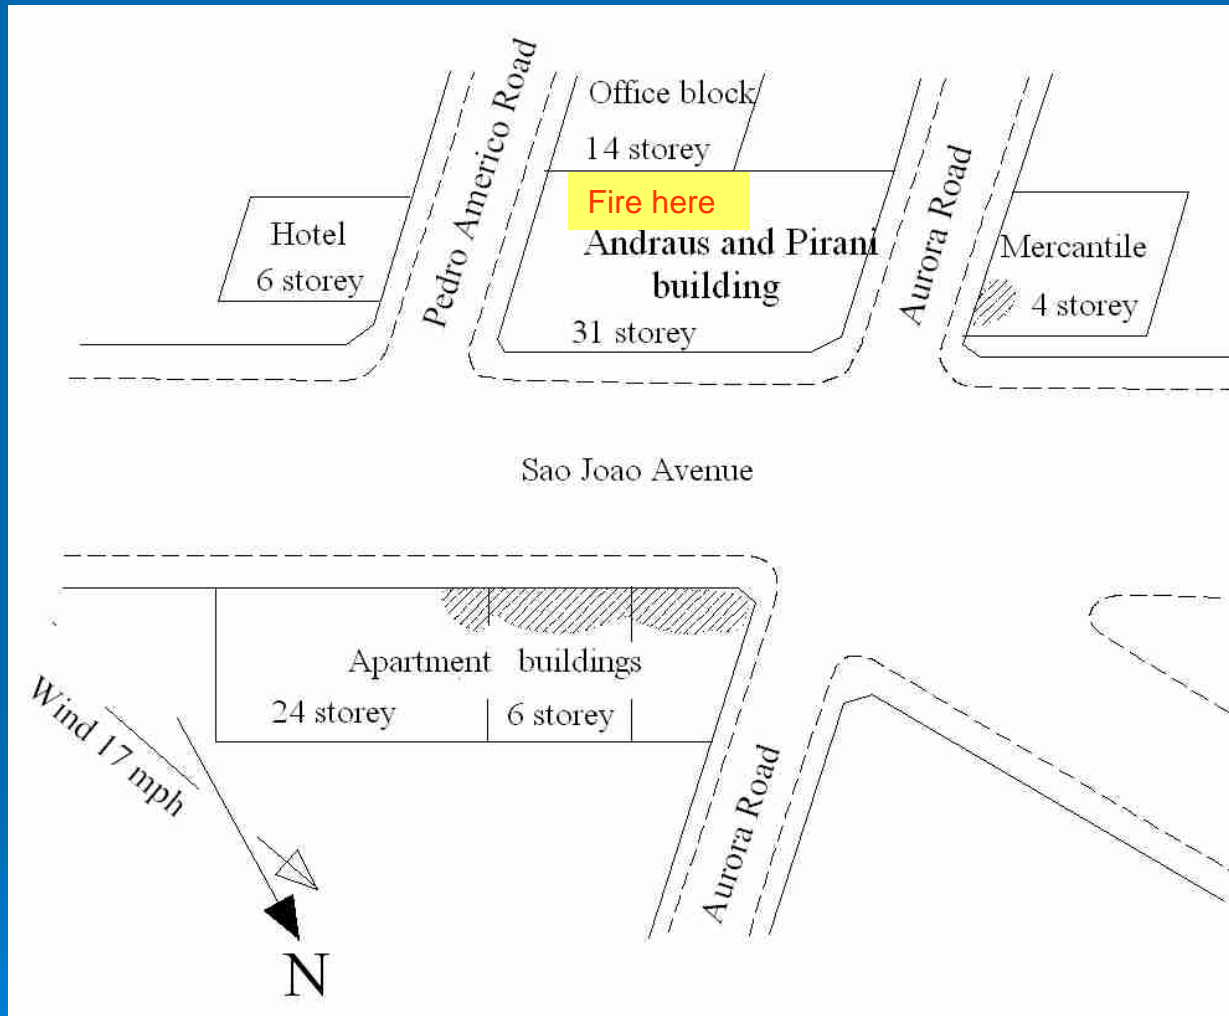
- Andraus site.
- Note damage to nearby buildings across streets (shown shaded)
- Note also wind direction

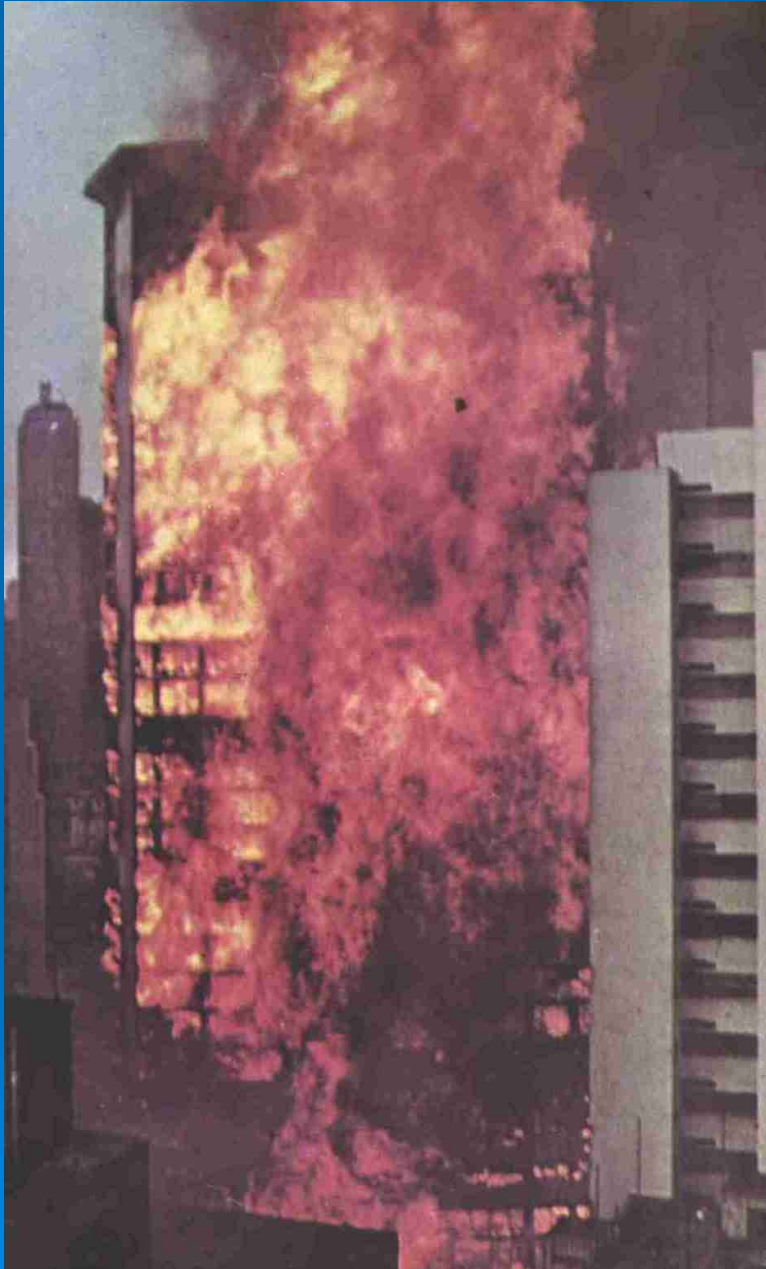
- Andraus office fire
- 31 storeys
- Fire started on 3rd floor
- 4 open staircases
- One protected spiral staircase
- 1000 people in building
- Timber partitions and ceilings
- 350 rescued by helicopter
- 100 rescued across ladder

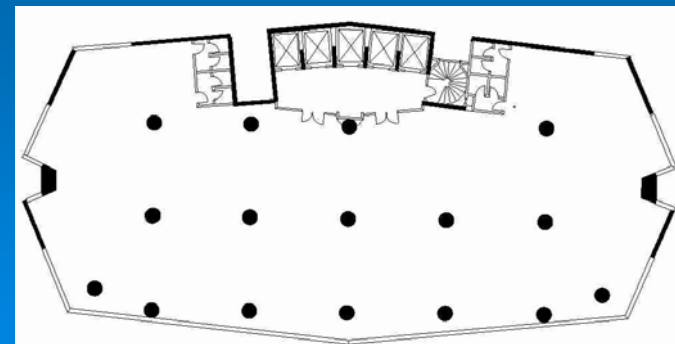
Andraus – the open plan arrangement on upper floors

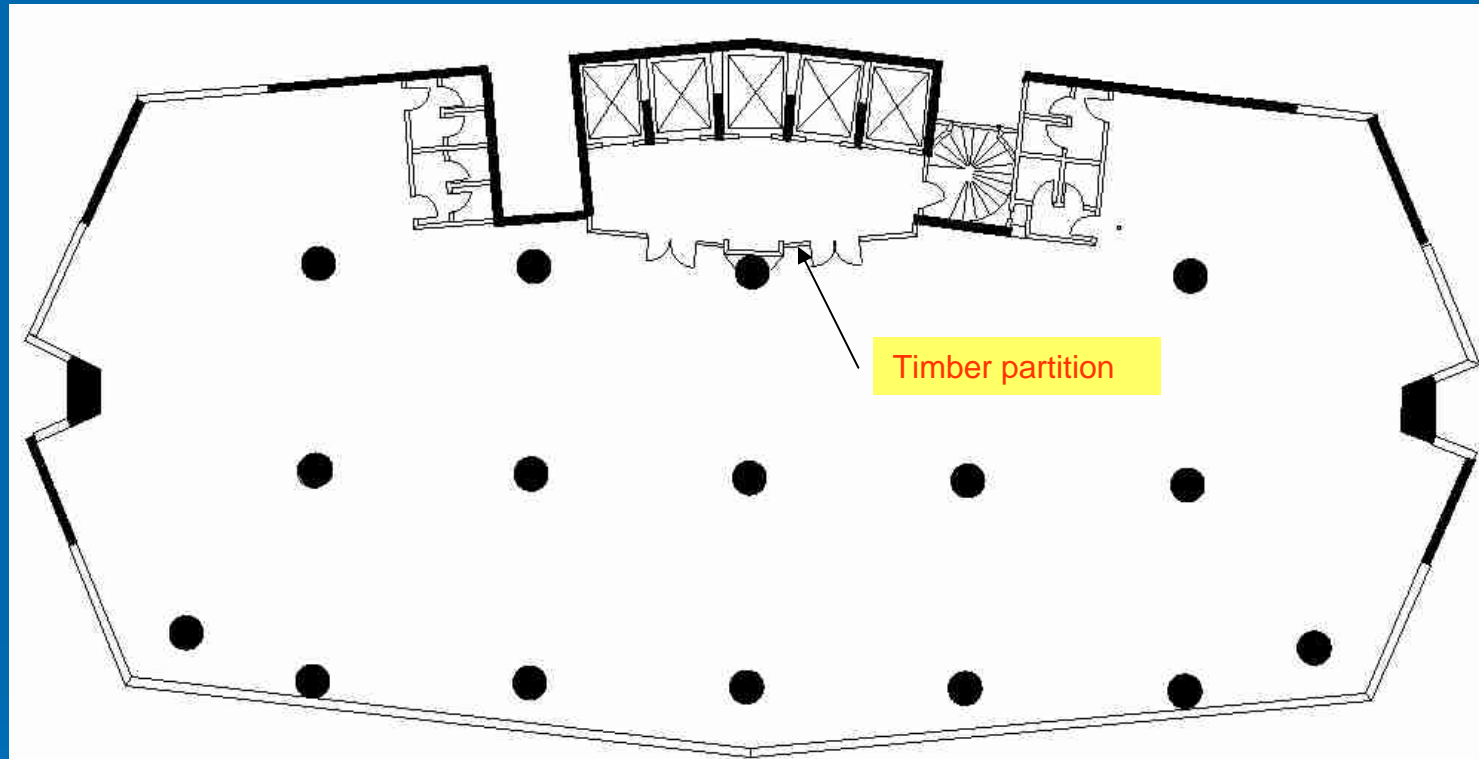
Typical office floor. Note open plan arrangement with no lobby fire protection to staircase and elevators. Timber partition would burn through rapidly allowing fire spread from office floor into staircase and elevator area

- Unprotected staircases and lifts formed shafts through which smoke and fire could and did spread.
- Ceilings were highly combustible and once involved in fire produced large external flames causing fire to be spread from storey to storey externally. The phenomenon of massive flaming associated with wood fibreboard linings was shown in tests made by BRE in the 1960's, though only the effect of flames from a single storey fire was investigated.
- The method of rescue using horizontal ladders between buildings was very unconventional and risky but brave and apposite (100 saved)
- Rescue by helicopter was successful in this case, but it depends on good weather conditions and absence of a smoke/heat plume. It is not an accepted mode of escape in the UK.
- Despite the severe fire the building remained standing after the fire.

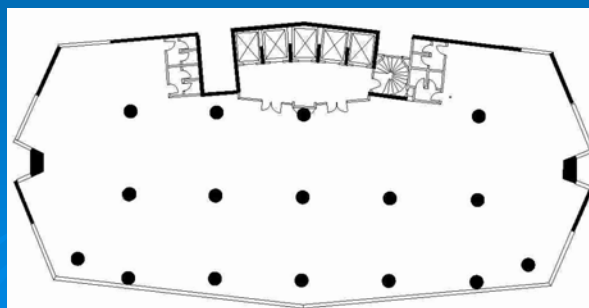
- 200 were trapped on the protected staircase because the heliport was overcrowded
- 100 of these were rescued at 14th floor level by the fire brigade using two ladders spanning horizontally from an adjacent building 24 ft away.
- Rescue by helicopter began at 17.15 hours.
- One man jumped to his death from the roof and another slid down the lightning conductor and also died.
- Panic took place on the roof which made rescue by the helicopter crew and fire crew hazardous.
